# Düzce University Journal of Science & Technology

Research Article

## Investigation of Corrosion Fatigue Crack Growth in Aluminium Alloy-Based Metal Matrix Composites: A Comparative Study

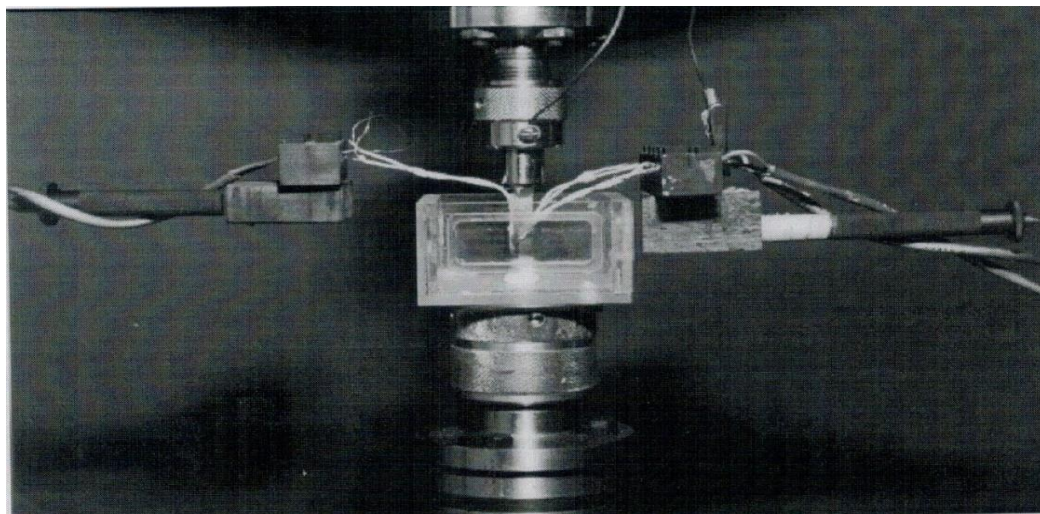
*Figure 1. Vibraphore tester with salt solution environmental chamber and AC PD wire connection*

The materials were 2124 (Al-Cu-Mg-Mn) Al alloys with 25 vol% SiCp MMCs. All materials were manufactured by Aerospace Composite Materials (UK) and were designated as AMC225 (25 vol% 2-3  $\mu\text{m}$  SiCp). Prior to machining, solution annealing was carried out at 505 oC for 1 hour, followed by cold water quenching and then natural ageing (T4) at room temperature. The alloy composition, particle size determination and distribution, and tensile response of these composites have been extensively investigated and discussed elsewhere [9]. For the evaluation of fatigue crack propagation, a 5x5 mm 'corner crack' (CC) specimen was adopted. A crack was initiated from a 0.25 mm deep edge slit. Pulsed direct current potential drop (DCPD) systems were used to monitor crack growth. At pre-determined stages of the test, a constant DC power supply delivered a 50A, two pulse to the specimen for 2 s while the fatigue cycles were held at 75% of the peak load.

During this period, the potential drop across the crack was measured. The potential drop data were converted to length and the FCGR was evaluated as a function of the applied stress intensity range  $\Delta K$  [10]. The effects of cyclic frequency (55Hz), stress (R) ratios  $R=0.1$ ,  $R=0.3$ ,  $R=0.5$  and  $R=0.9$  and 1 Hz sinusoidal waveform were applied to all specimens. All tests were performed under constant amplitude load control test conditions using the Ampsler Vibraphore testing machine. All tests were carried out in air and 3.5% saline solution. A typical specimen and the DCPD wires are shown in Figure 1. The fracture surfaces of the specimens were observed in a Jeol 35c SEM to determine the dominant fracture modes and to characterize the fine scale topography of the fatigue fracture surfaces.

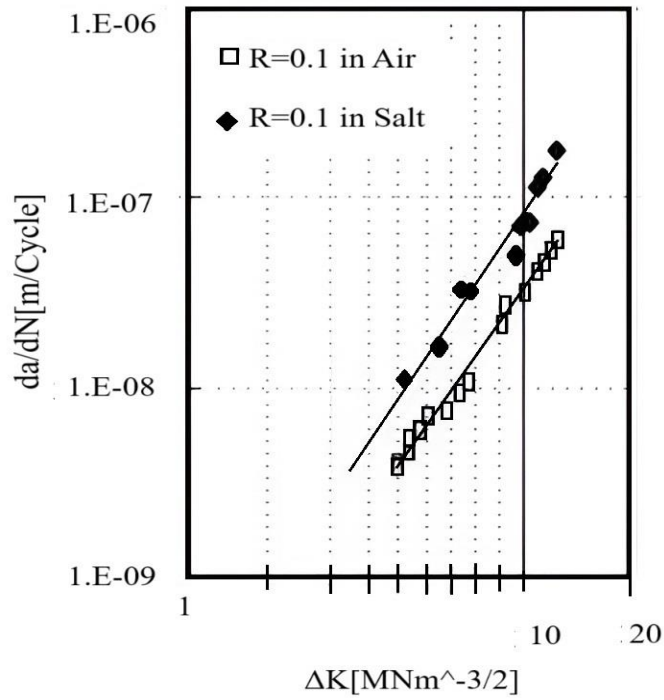
**Figure 2.** The effect of 3.5% NaCl solution on the FCGR at  $R=0.1$  for AMC225-T4

Comparisons of crack growth rates in air and salt solution environments at various R-ratios are shown in Figure 2-4 for the MMC material AMC225. It is clear that there is a strong environmental enhancement of the crack growth rates. In particular, the FCGR increased by a factor of 4 in the aggressive environment at R=0.1 (see Figure 2). However, the effect of the hostile environment on crack growth rates decreased as the R ratio increased (see Fig. 3 and Fig. 4). The effect of the saline solution on the FCGR is shown in Figure 5 for the AMC200 base alloy. For an equivalent  $\Delta K$ , the FCGR increased rapidly in salt solution compared to air. However, unlike the MMC, there is no reduction in the FCGR of the base material as the R ratio increases. It can be said that as  $\Delta K$  values and general growth rates increase, the effect of the environment on FCGR decreases due to the dominant role of static fracture modes and the relatively reduced time available for any interaction to occur.

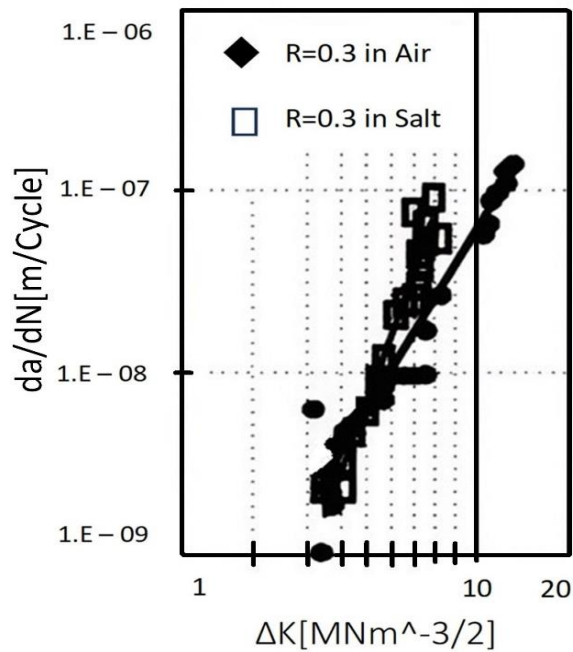
**Figure 3.** The effect of 3.5% NaCl solution on the FCGR at  $R=0.3$  for AMC225-T4

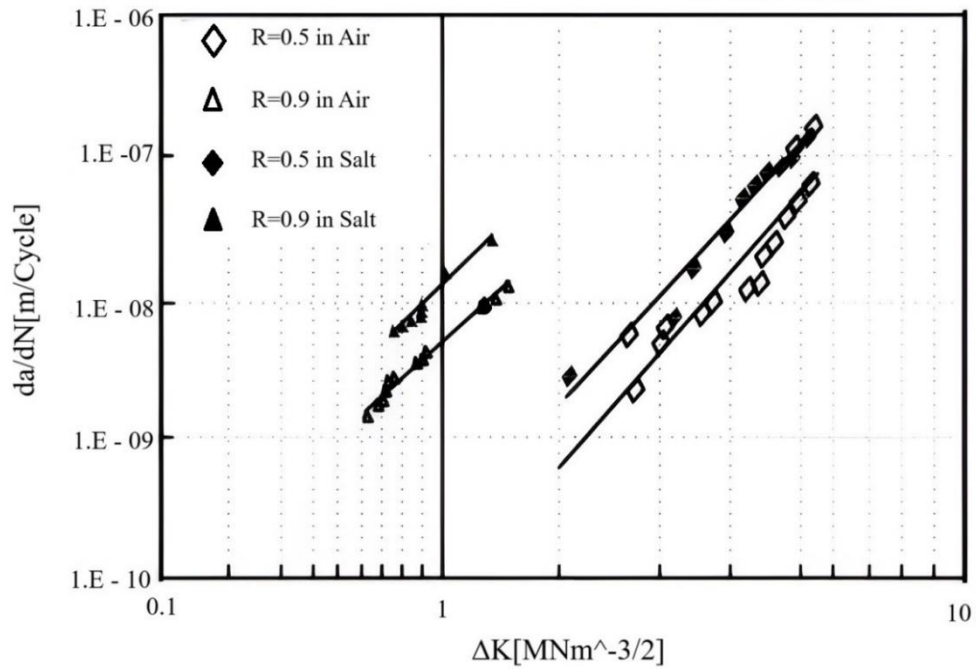
**Figure 4.** The effect of 3.5% NaCl solution on the FCGR at R=0.5 and R=0.9 for AMC225-T4

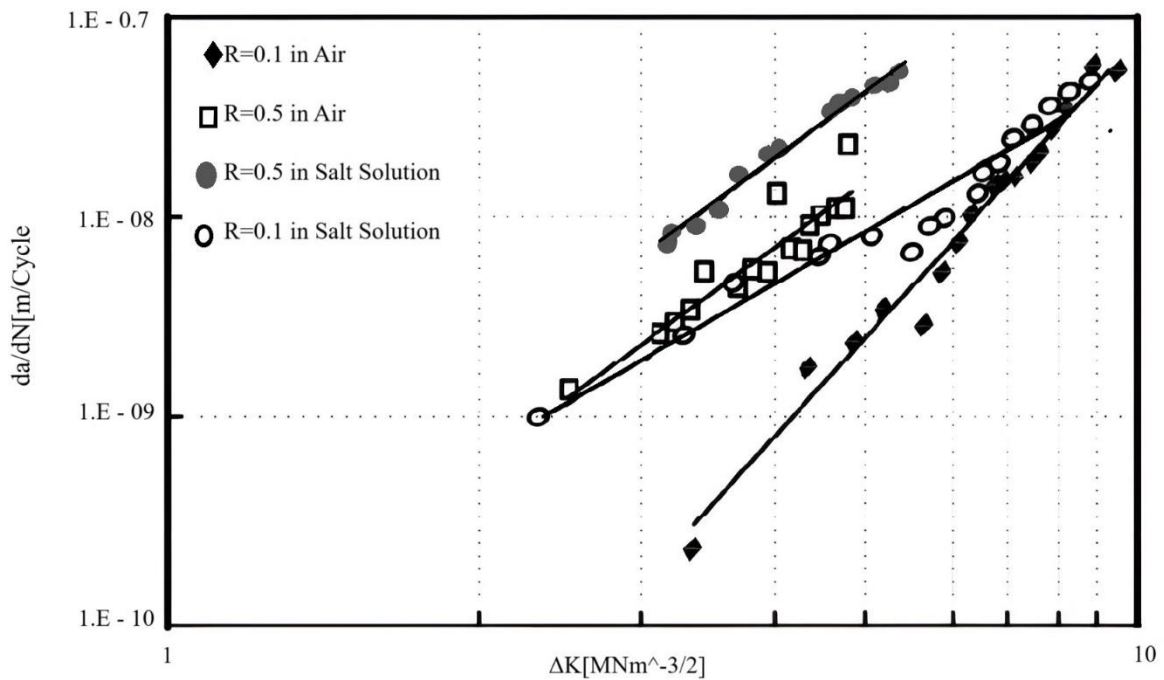
**Figure 5.** The effect of 3.5% NaCl solution on the FCGR at R=0.1 and R=0.5 for AMC200-T4 unreinforced base material at a maximum applied stress of 150 Mpa

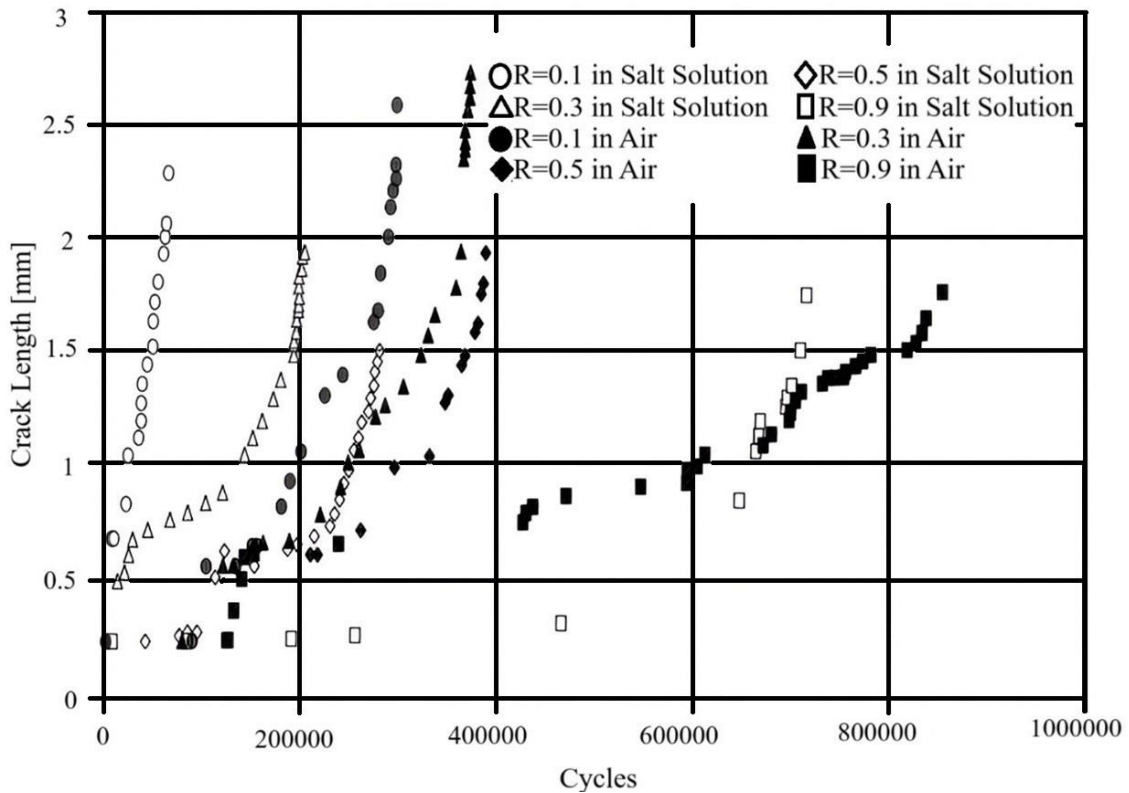
**Figure 6.** The effect of environments on crack length of AMC225-T4 MMC material with various stress ratios

Figure 6 summarizes the effects of environment on crack growth for AMC225 MMC material in terms of crack length versus cycles. It can clearly be seen that the life to failure is 5 times longer in air than in the 3.5% salt solution environment at R=0.1. However, the difference between the two environments decreased as the R ratio in salt solution increased. For example, at R=0.9, the life differences between air and saline environments were only 17%. The largest effect of the environment was observed at R=0.1 for AMC225. It is well known that corrosion fatigue is a time-dependent phenomenon. The acceleration of FCGR and the reduction of the threshold stress intensity range  $\Delta K_{th}$  in salt solution have been reported previously for Al alloys [10]-[12].

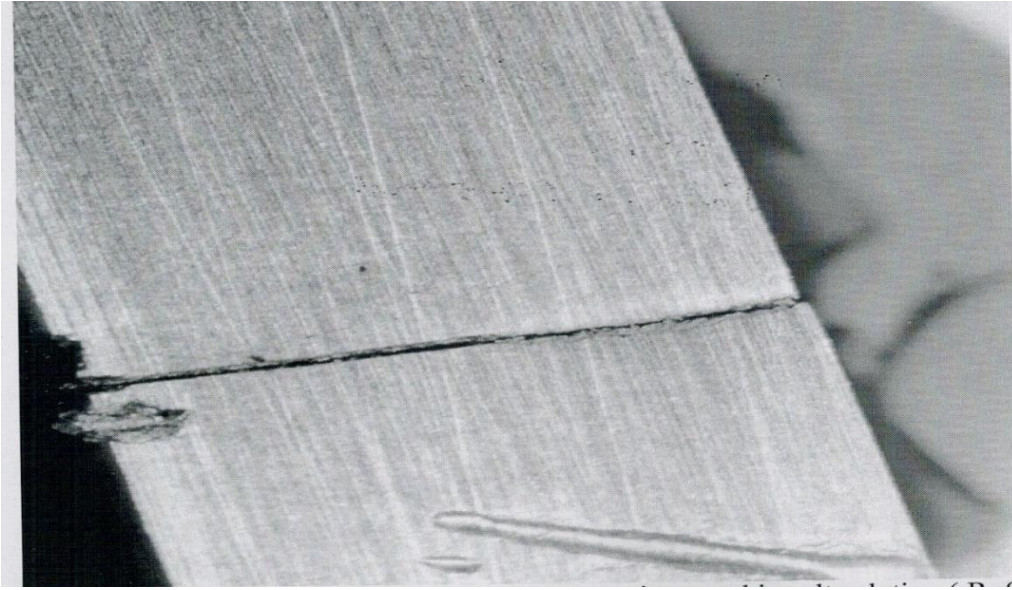
**Figure 7.** Fatigue crack path of AMC 225 composite tested in salt solution ( $R=0.5$ ,  $\sigma_{max} = 175$  MPa,  $N_f = 265000$  cycles)

The fracture behaviour of the specimens was investigated using the SEM. The specimens examined were tested at the same stress level (150 MPa). The fracture behaviour of all materials is compared in Figures 7 to 9 at magnifications of 17x and 3500x. In the composite material the crack was perpendicular to the applied tensile stress. All composite samples failed in a similar manner in air or salt solution and at the various stress ratios. It can be seen that the crack started from a 0.5 mm slit and grew in a quarter circular fashion to a length of 5 mm<sup>2</sup> when fast fracture occurred in air (see Fig.8.a). A typical high magnification SEM image of the composite is shown in Fig.8.b. At the low  $\Delta K$  values, the fracture surfaces were featureless and very flat. However, at stress intensities of  $6\text{MPa}\sqrt{\text{m}}$  the appearance of the fracture surface changed (see Fig.8.b). The fracture surface was quite rough with many peaks and valleys. Extensive deformation was observed around the SiC particles. The SiCp were associated with large ductile pits and the Cu<sub>2</sub> Mn<sub>3</sub> Al<sub>20</sub> precipitate particles with small pits. Typical SEM images of the composite in a salt solution environment are shown in Figure 9.a and b.

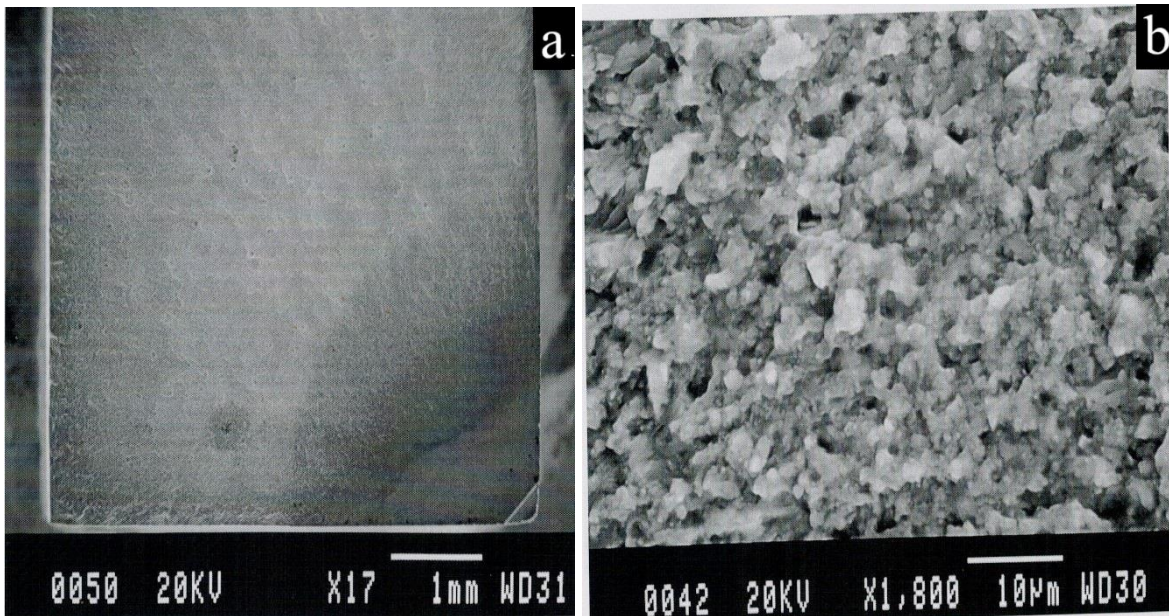
**Figure 8.** a) Fracture surface of AMC225 in air b) Fracture surface of the same MMC in the overload region. The fatigue crack has propagated from left to right

Comparison with room temperature fracture surfaces showed that there was no major difference in fracture mode and crack growth mechanism. However, typical differences in fracture surface appearance were observed; i: the semicircular slow crack growth region was 2 mm<sup>2</sup> in salt solution, which is significantly smaller than in air (5 mm<sup>2</sup>), ii: corrosion products occurred on the fracture surface. EDX analysis of the dark areas showed that these were composed mainly of Cl and Na residues. iii: Crack growth fracture surfaces were rougher than in air (see Fig.8.b and Fig.9.b). iv: Many individual microcracks were observed in the stage II growth region in salt solution. v: Fracture particles were more prominent in salt solution than in air. The alloys investigated exhibited brittle fracture behaviour in both environments, as evidenced by the presence of cleavage facets and quasi-cleavage areas on the fracture surfaces. However, the more hostile environment resulted in a flatter fracture surface, enhanced particle interface cleavage and particle cracking, and promoted corrosion pits on the fracture surface (Figure 9.b). In general, in saline environments, freely initiated corrosion fatigue cracks often originated from pits caused by exposure to the hostile environment [16], [17].

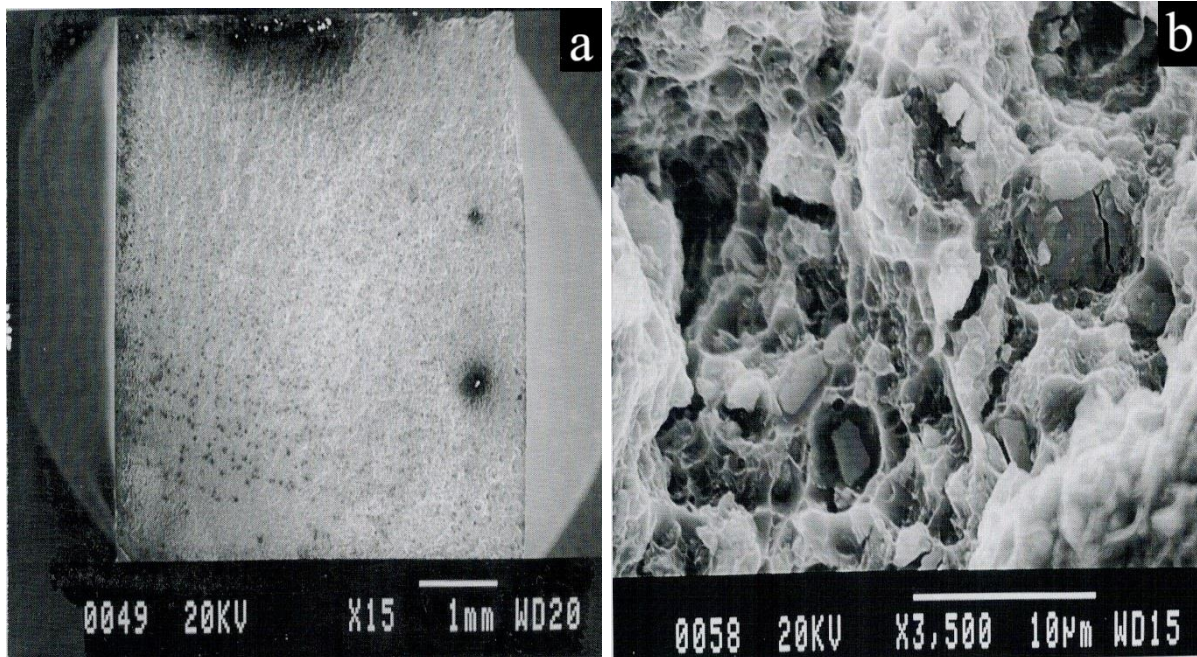
**Figure 9.** a) Fracture surface of AMC 225 in salt solution b) Fracture surface of the same MMC in the overload region. The crack propagates from left to right
