Some Observations on the Architecture of the Roman Theatre of Iznik (Nicaea)

Aygün Ekin Meriç* - Ali Kazım Öz**

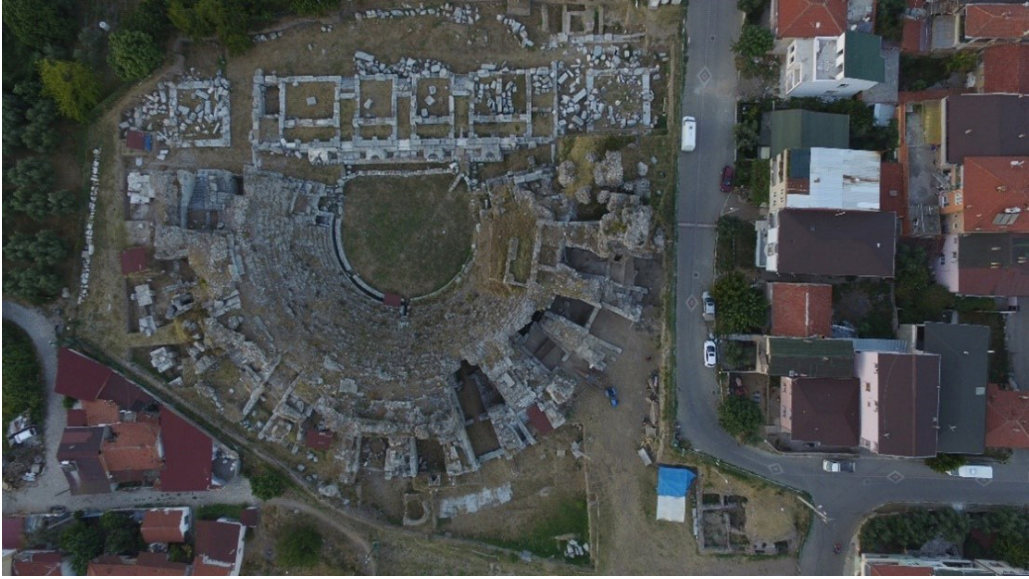
Fig. 3. General view of theatre (courtesy of the Roman Theatre Excavation at Nicaea 2021)

Nicaea was located beside a wide lake and fertile plain; therefore the importance of the city increased throughout all periods¹. The city, which is notable for its climate and geographical features, was a social, political, and economic center of the Bithynia Region (fig 1). It has always been one of the most important cities in Bithynia during the Hellenistic, Roman, Byzantine, Anatolian Seljuk, and Early Ottoman Periods. The most remarkable structure of the city, which hosts many buildings from the Roman Period to the Ottoman Period (fig. 2), is the Roman theatre (fig. 3).

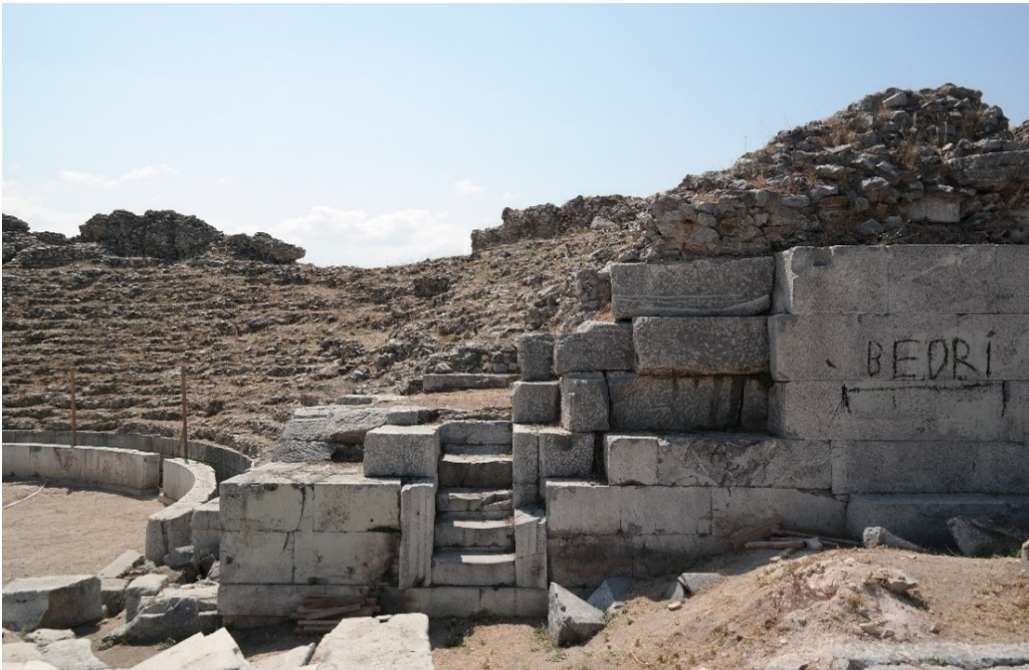
Fig. 4. Remains of cavea and west analemma (courtesy of the Roman Theatre Excavation at Nicaea 2019)

The north-facing theatre has a unique vaulted substructure, which is rarely found in ancient times, as it was built on a flat area with very large dimensions²⁴. The Nicaea Theatre was constructed using the *opus caementicium* (Roman concrete) technique using rubble stone and mortar. According to recent research, the boundaries of the theatre have been determined as 102.32 x 79.04 m (fig. 5). The surfaces of the *scaenae* and *analemma* walls were covered with limestone blocks. There are various symbols of workshops or master builders who processed the stone *in situ* or in quarries such as Deliktaş, İnikli, Ömerli, and Sarıkaya²⁵. Many parts were removed from the theatre and used in various buildings as well as the city walls. Therefore, the stage building, orchestra floor, analemma walls, arches, and vaults were subsequently destroyed (fig. 4).

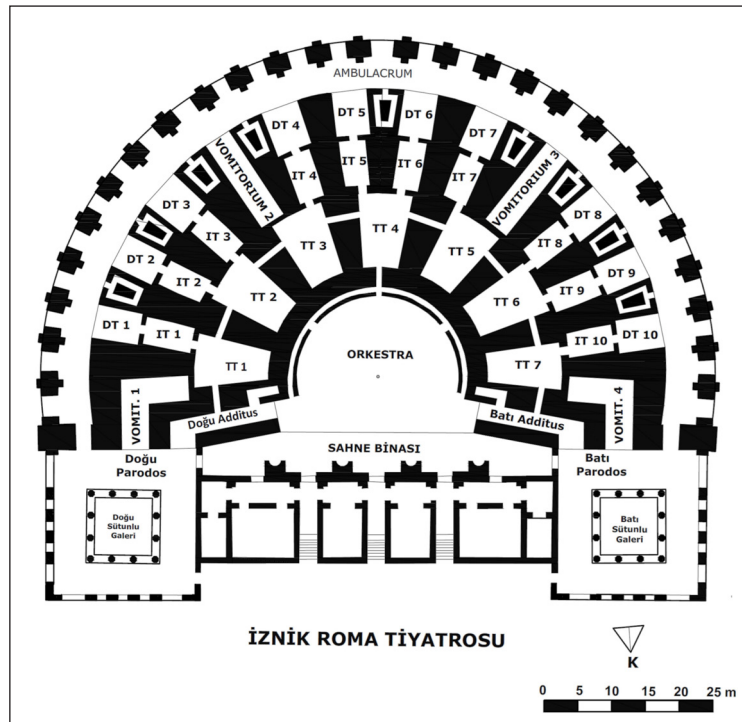
Fig. 6. Infrastructural plan of theatre (drawing A. K. Öz 2018)

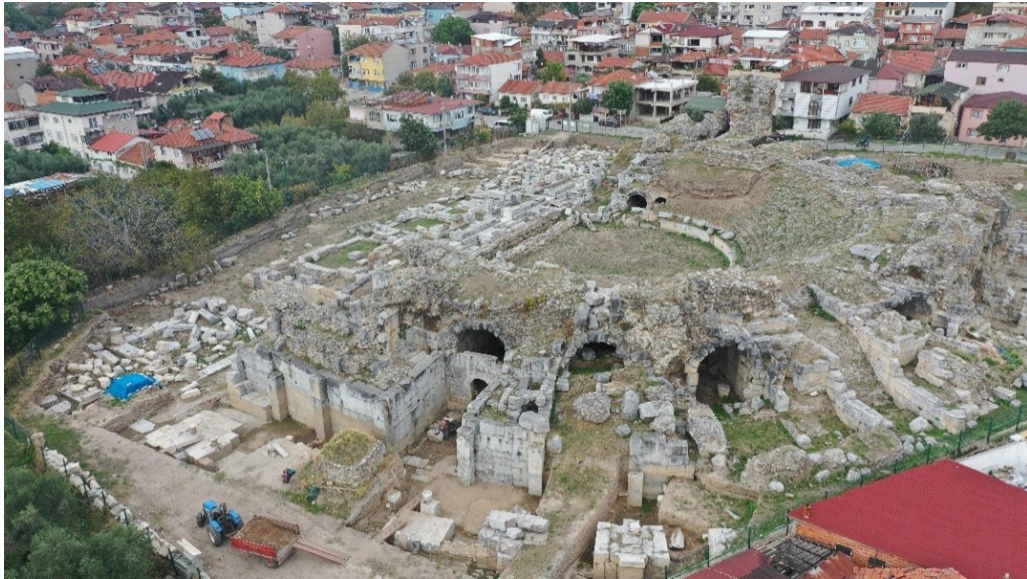
Fig. 7. Imposing vaulted infrastructure of cavea (courtesy of the Roman Theatre Excavation at Nicaea 2020)

The infrastructure was formed by trapezoidal vaults and a double barrel vault system that supports the middle cavea (fig. 7). The outer vaults were added to the middle cavea along with the staircase chases that followed. Based on the archaeological evidence obtained from the excavations, it was understood that the theatre consisted of three parts. The subdivision (*ima cavea*) was reserved for the executives, priests, soldiers, and high-ranking Roman citizens who attended the performances³⁰. The lower cavea was separated from the orchestra floor by a deep *conistra*³¹ measuring 1.34 m in height. Based on a small number of preserved blocks, it was determined that the seating positions were 0.69 m in depth and 0.39 m in height. Additionally, some of the seating rows are backed in order to be used as *prohedria* (protocol or noble seats) or as a barrier for the *praecinctio* (diazoma). In contrast to the Greco-Roman architectural tradition³², the plan of the theatre is formed by eight *cunei* (wedge-shaped seating sections) with *scalae*³³ (stairs) between them and 18 rows of seating (figs. 8-9).

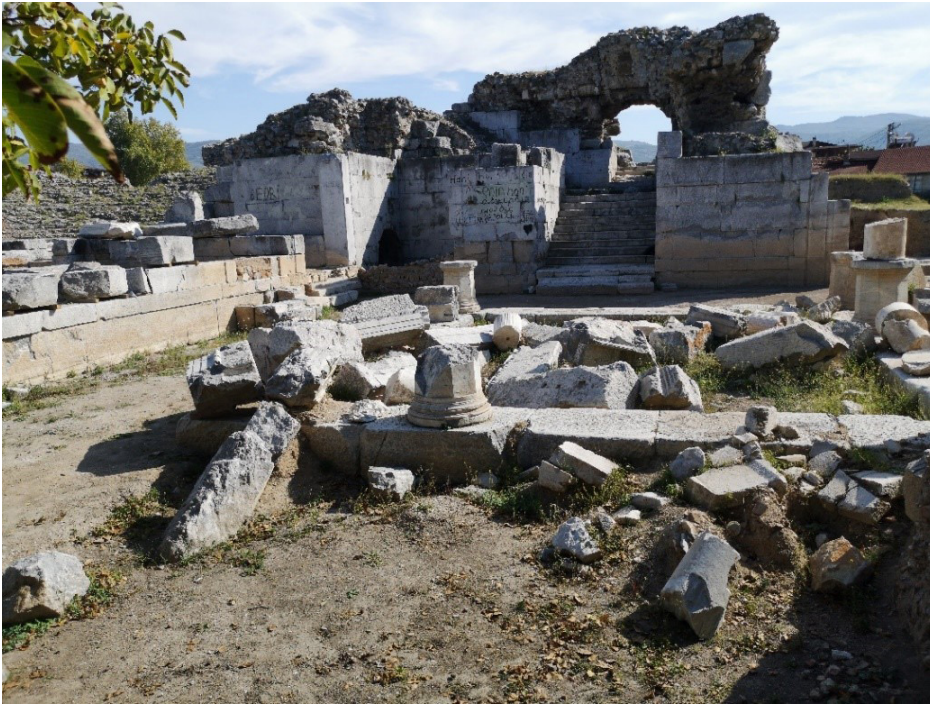
Fig. 10. Blocks of the west portico and vomitorium (courtesy of the Roman Theatre Excavation at Nicaea 2020)

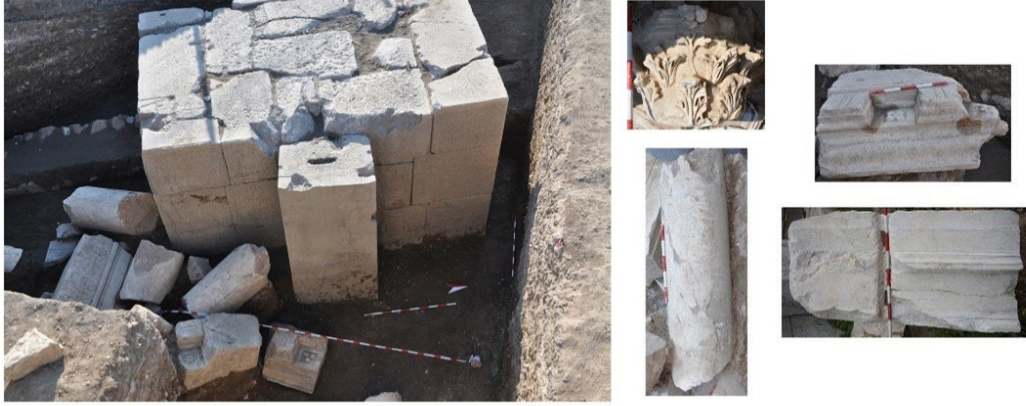
Fig. 11. Fallen blocks from the portico of upper cavea (courtesy of the Roman Theatre Excavation at Nicaea 2020)

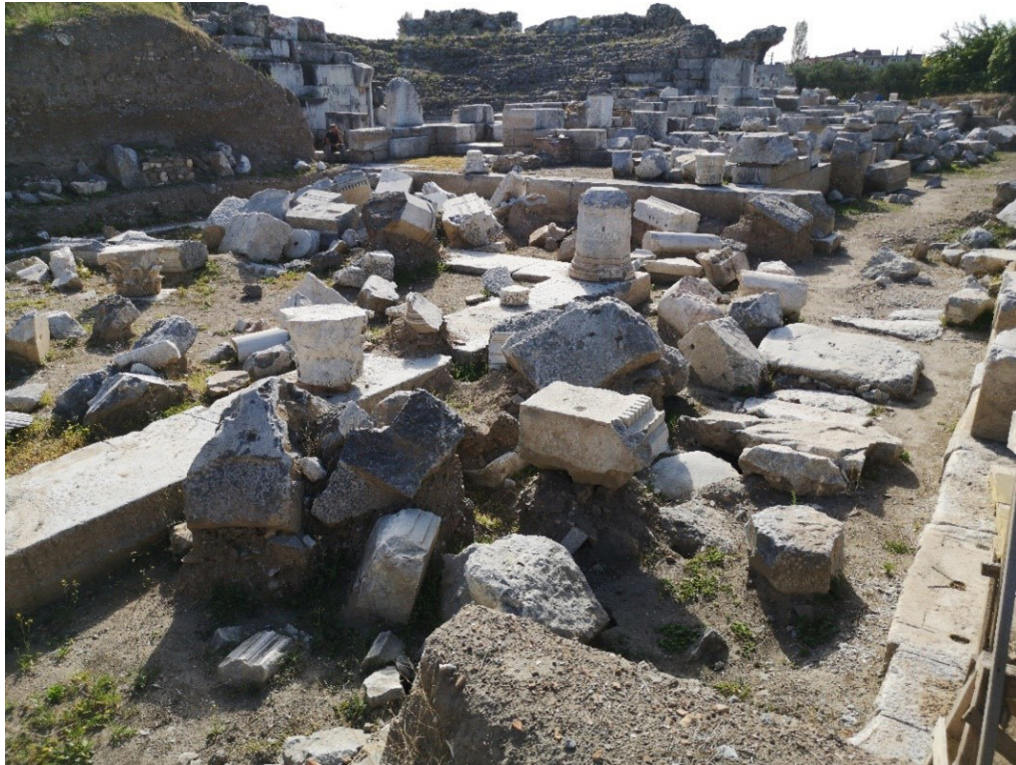
Fig. 12. View from scaenae to cavea (courtesy of the Roman Theatre Excavation at Nicaea 2020)

At the end of the excavations, the entire *scaenae*, measuring 54.15 x 13.16 m, was uncovered (figs. 8, 12). Only the architectural features of the stage building, whose infrastructure plan is preserved, can be interpreted based on the remaining structures. According to this plan, there are three main entrances and four main rooms separated by an aisle. The stage rooms of the theatre, known as *choregia*, were used for storing decorations and costume changes⁴⁹. Additionally, there were eight smaller rooms for service purposes surrounding the main rooms. Among these rooms, those forming the outermost line of the stage building were likely used as *prascaena*. The excavations have not revealed any evidence of a *porticus post scaenum*, which is expected to be located behind the stage building. Because most of the area where the *porticus post scaenum* will be located lies outside the fenced excavation area. If the fenced area is expanded northward in the coming years, more definitive information about the porticus post scaenum may be obtained⁵⁰. It can be considered that the four rooms in the southern part of the stage building form a long and high corridor in connection with each other, because we know of similar examples from theatres such as Aspendos⁵¹. The excavations have not found any evidence of *porticus post scaenum*, which should be behind the stage building.

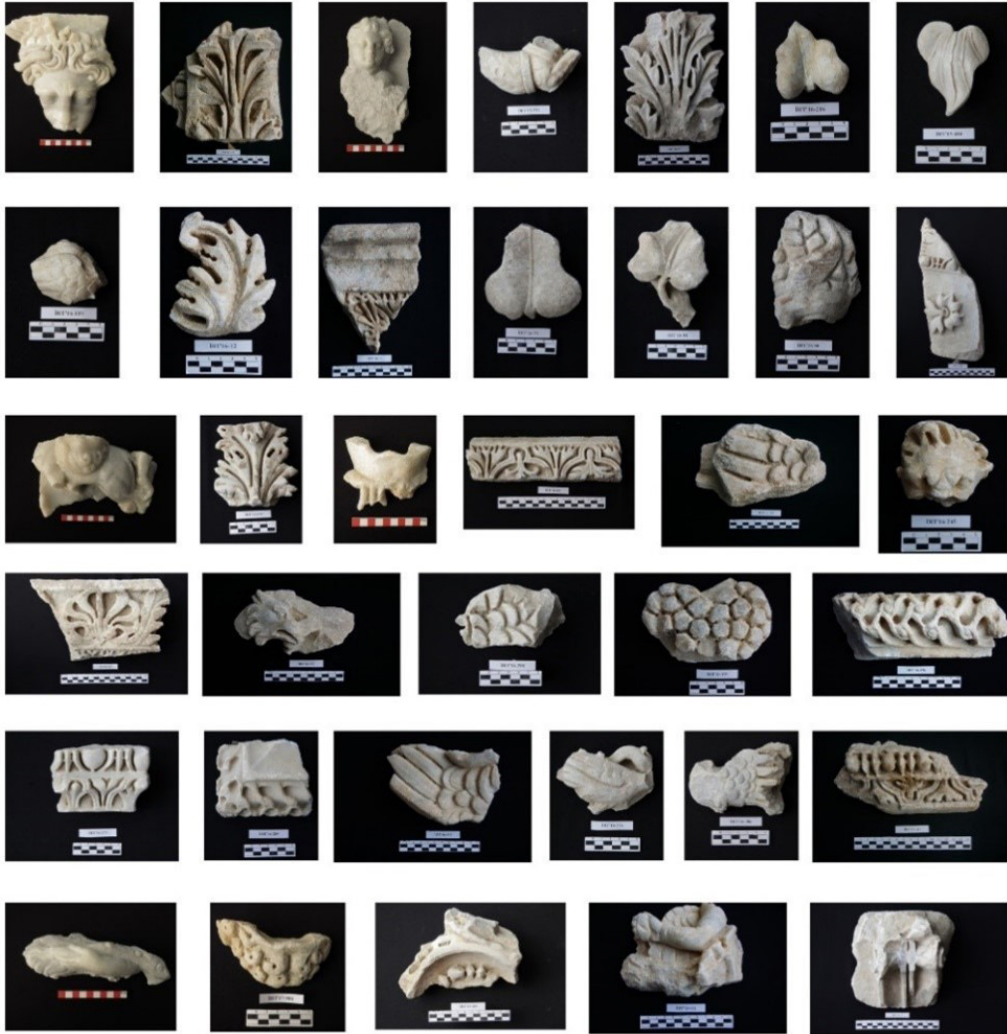
Fig. 13. Architectural fragments of stage building (courtesy of the Roman Theatre Excavation at Nicaea 2020)

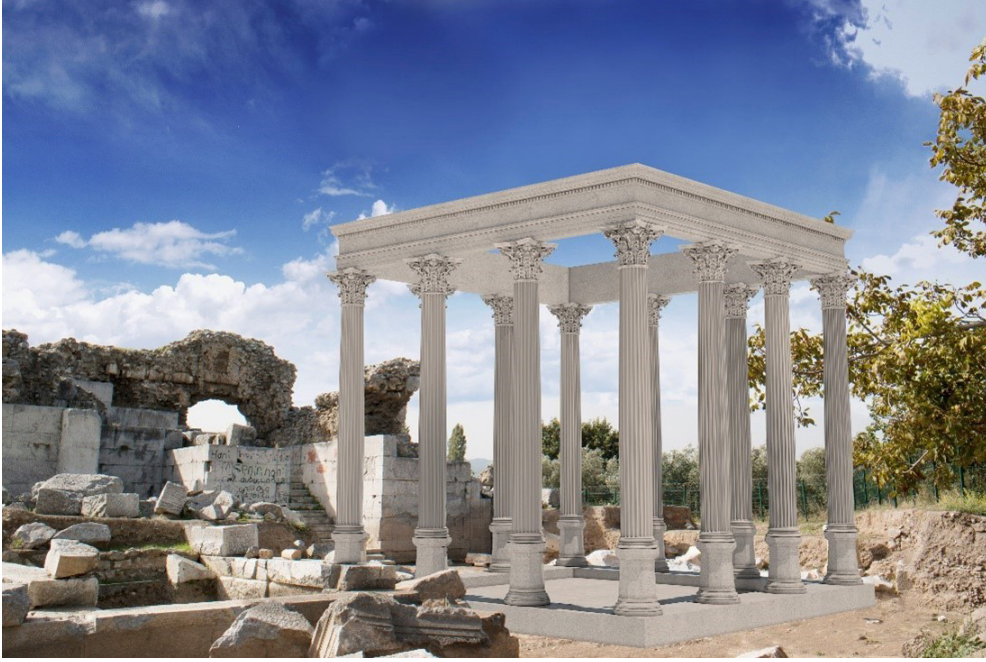
Fig. 15. Reconstruction of west portico (drawing F. H. Kaya; V. C. Caner, 2016)

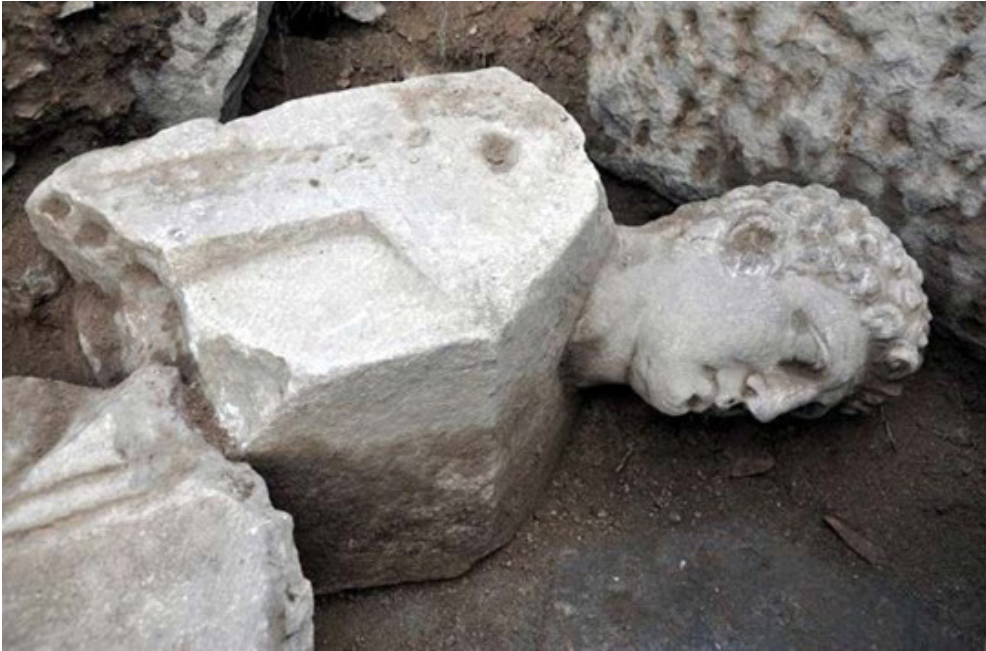
Fig. 16. Hermae in east portico (courtesy of the Roman Theatre Excavation at Nicaea 2017)

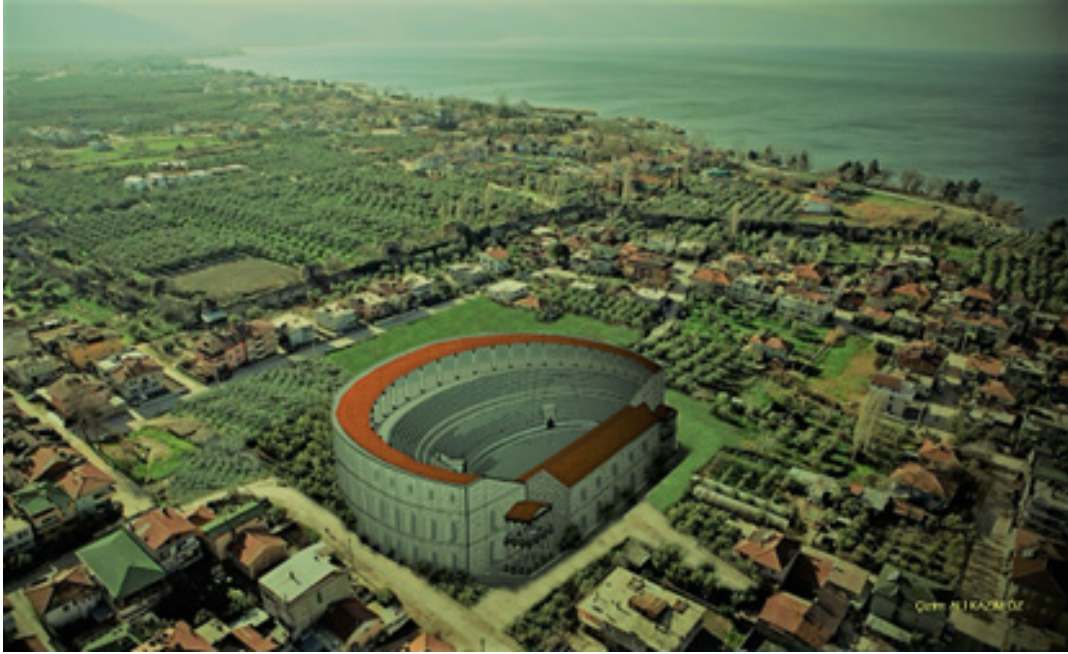
Fig. 17. Possible reconstruction of theatre (courtesy of the Roman Theatre Excavation at Nicaea 2021)

Finally; The recording, Restitution (fig.17) and Restoration Project of the Roman Theatre at Nicaea was prepared in order to protect the multi-layered character, prevent physical destruction and transfer to the future generations in accordance with conservation principles.
