## A QUALITY CONTROL SYSTEM PROTOTYPE FOR DETECTING KNOT DEFECTS IN THE WOODEN PANEL MANUFACTURING

Kilic, O., Susuz, D.M., Suzek, B.E., (2019). "A Quality Control System Prototype for Detecting Knot Defects in the Wooden Panel Manufacturing", *Mugla Journal of Science and Technology*, 5(1), 24-33.

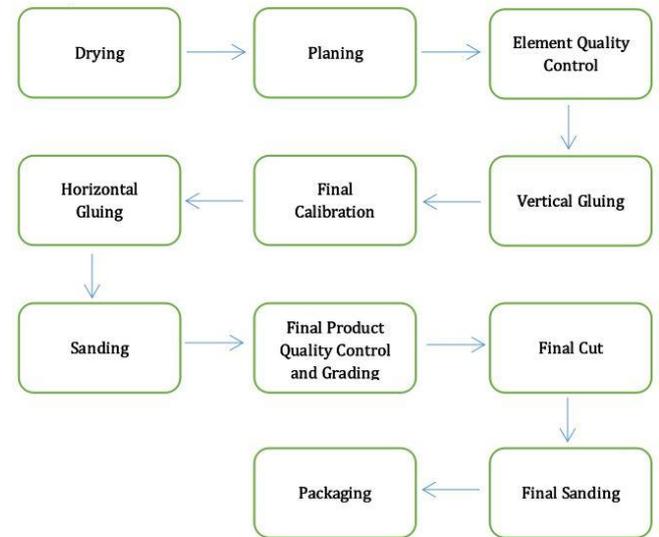
Figure 1. Wooden Panel Manufacturing Process.

Having elements as primary input, the steps of the wooden panel manufacturing process shown in Figure 1 are summarized as follows.

**Drying:** Elements are dried to minimize the moisture in them. After this step, elements become lighter, stronger and they will have more resistance to distortion.

**Planing:** Dried elements are planned to have smooth and flat surfaces. At the end of this step, each element has the identical width and thickness that are 48x48 mm. The speed of the planing machine can reach to 11 m/min.

**Element Quality Control:** Each element processed by the planing machine is subject to following controls and classifications conducted by quality control inspectors:

**Vertical Gluing:** After successful completion of quality control phase elements are glued vertically by locating the non-defective surfaces in the same direction. In order to adhesion of glue the edges are shaped as finger joints. The output of this step is a stick called lamella with a length of 6.5-6.7 meters.

**Final Calibration:** The lamellae, output of the vertical gluing, are processed in the planing machine and their width and thickness are reduced to 42 mm.

**Horizontal Gluing:** After the final calibration, lamellae are glued horizontally by having their non-defective surfaces on the same side. If the elements are subject to color or grain classification then lamellae are selected according to their groups in this step. As a result of this step, a crude panel is formed.

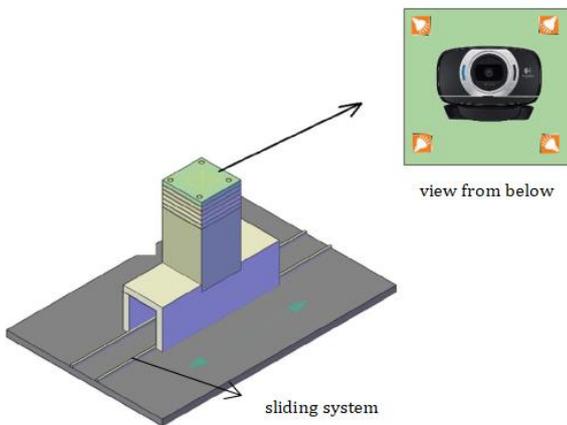
Figure 2. Prototype Scanner.

knot defects) elements by the quality control inspector of the company and used in the testing our methodology. A prototype scanner was designed and crafted to capture element surface videos. Figure 2 shows the design of this scanner that scans the upper surface of the element. The prototype scanner moves horizontally on a sliding system and thus simulates the conveyor belt mechanisms used in the real production environment of a wooden panel manufacturing plant. To easily differentiate the background from that of the element surface, the sliding systems' color was chosen as white. Comprised of a 30 cm long 10x10 cm tunnel, and a 30 cm high 10x10 cm tower in the middle of the tunnel, the prototype scanner is designed to eliminate any potential outside/external light effect during the video recording. A high-resolution camera (Sony Cybershot DSCW300) is projected vertically down from the top of the tower to capture element surface videos with speed of 30 frames per second. Due to tower height and FoV of the camera, each video frame contains 12 cm of the element surface in length (no limitation on width). The scanner is also equipped with two internal LED light sources. The location and angles of light sources were critical. Direct light causes glare on the element surface and this distorts captured video. On the other hand, insufficient light due to a wrong angle results in shadows and/or poor quality videos. Based on our experiments, positioning the two LED light sources in either tunnel entrances facing the tower horizontally gave the best video quality.

Finally, in this phase, the scanner is used to capture 100 element surface videos, 50 of which is with knot defect and the remaining is without knot defect. These videos are processed and prepared for detection in the following phase.

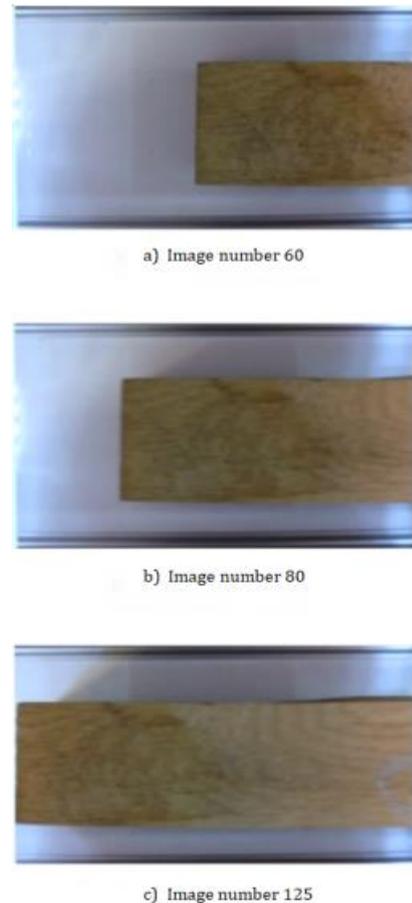
Figure 3. Image Flow.

elements just begin to enter into or start leaving the camera's FoV. In Figure 3, three images extracted from the video of an element are shown. Image 60 shown in Figure 3a is the 60th frame of the video, image 80 shown in Figure 3b is the 80th frame of the video and image 125 in Figure 3c is the 125th frame of the video. In Figure 3a and Figure 3b the element has just entered into the frame but does not span the frame from end-to-end, therefore the white background is visible between the left edge of the frame and the left edge of the element. Similarly, while leaving the frame a gap is formed between the right edge of the frame and the right edge of the element. The image in Figure 3c displays a surface from right edge of the frame to the left edge of the frame and this image overlaps with the surface region displayed in Figure 3a and Figure 3b. There is no need to process frames which contain partial element surface since they are already contained in another frame. Furthermore, as seen in Figure 3, the amount of white background in frame 60 and frame 80 is much more than the frame 125 and having more background in an image introduces additional noise that can lead to false defect detection. Hence, the first step of video processing is to eliminate frames which contain partial element surfaces. In order to distinguish the element surface from the conveyor belt surface, elements are carried on a white colored belt.

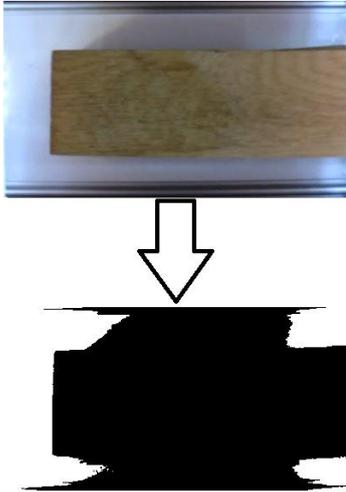
Figure 4. Image Extraction and Selection.

To detect the images containing partial surface, first, black and white conversion is performed on the images extracted from the video using a fixed threshold as shown in Figure 4. Rectangular white areas in right and left edges of video frames are used as indicators of partial element surface image and such frames are eliminated from the beginning (or end) of the video.

Given the video has 30 images per second, consecutive video frames have many overlapping regions. Hence, after eliminating the frames with partial element surface, from the remaining frames a subset of frames covering the full element surface is selected sequentially following the video frame order in equal intervals. As the selected frames are used for knot defect detection in next phase, the number of selected video frames must be large enough to cover whole element surface but small enough to improve knot detection by limit the number of frames processed. Although in a panel manufacturing plant, the interval between selected frames is dependent on and adjusted according to the conveyor belt speed, for practical purposes, in this study, ten equal-interval video frames including the first and last video frames containing a full element surface image are selected. Selected images are then passed to the knot defect detection phase.

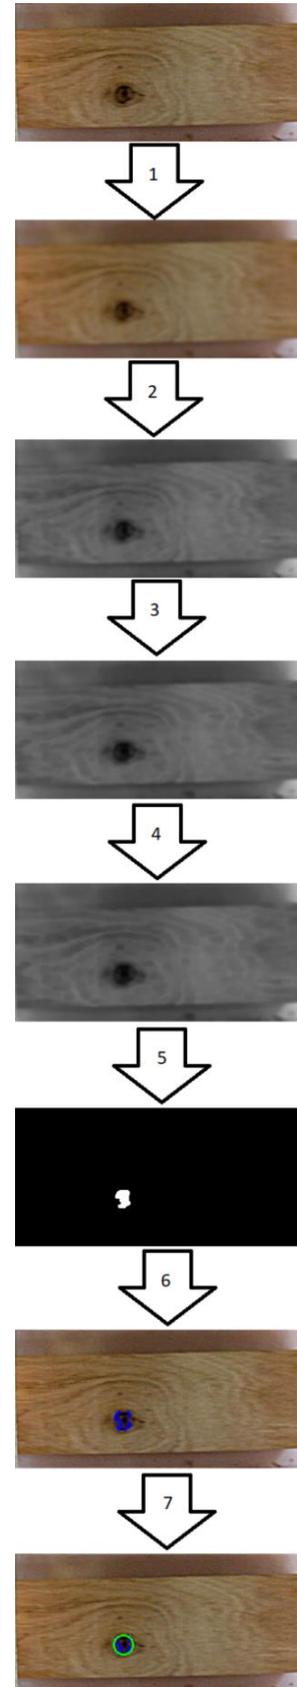
Figure 5. Knot Detection Steps.

In this phase, knot defects on the frames from earlier step are detected and tagged in several steps; image smoothing, grayscaling, image erosion, histogram thresholding to identify knot defect candidates, knot defect classification, and finally tagging the knot. Figure 5 shows knot defect detection steps for an element surface image.

The first step; image smoothing, is a technique to minimize noise by convolving the image with a filter kernel. We tested various filters including Averaging, Median, Bilateral and Gaussian filters and various matrix dimensions. Gaussian smoothing yielded the best result with an 11x11 matrix. This smoothing step also reduced the adverse effect of minor camera focus

problems, resulting in blurring on the original images, on knot detection. In Figure 5 Step 1, the smoothed version of an example element image after application of a Gaussian smoothing is shown.

The second step; grayscaling is a common practice used in image processing to simplify processing tasks when color information is not vital. Knot defect detection may be done in grayscale and should not be color-dependent, as the color tones change by to element's tree type and knot features are morphological and not color related. Grayscale of element image is done according to ITU-R (Radiocommunication Sector of International Telecommunication Union) recommendation BT.601-7 [39]. In Figure 5 Step 2, grayscaled element image is shown.

The third and fourth steps employ vertical and horizontal image erosions to reduce noise and detection adversities due to the tree growth rings and cracks. Image erosion is applied to remove noisy connections between objects [40]. In the wooden element case, its application contributes to easier differentiation of knots by increasing gaps between and thinning down growth rings. Our experiments resulted in erosion matrix sizes of 3x1 and 1x3 gave optimal results. In Figure 5 Step 3 and Step 4, vertically and horizontally eroded element images are shown.

In the fifth step, the histogram thresholding method is used to identify all knot defect candidates. This method allows detection of pixels that are darker than a threshold in grayscale such as the surface average tone. Given knot defects are rare and darker regions, a threshold value corresponding to pixels covering darkest 0.5% of all pixels on the element image is used. Lower and higher threshold values are tried but adversely affected the knot detection performance. Figure 5 Step 5 shows the application of histogram thresholding. Note that a knot defect candidate; white region, has been detected at this point.

In the sixth step, knot defects are identified from the list of candidates highlighted after histogram thresholding in the fifth step. A knot defect candidate, at this point, is a white region. First knot candidates are filtered based on a size if they are within tolerable range by wooden panel manufacturer (>90 pixels). Next, as knots are circular in nature, the circularity of the defect candidate, as shown in Equation (1) is measured by computing the ratio between the area of defect candidate and the area of the minimum enclosing circle which is calculated using the Welzl's algorithm [41]. The candidate is labeled as a knot defect if it has circular morphology. Figure 5 Step 6 shows a knot defect identified in this step.

In the seventh step, knot defects are marked on the original (color) element surface images using minimum enclosing circles in yellow as seen in Figure 5 Step 7.

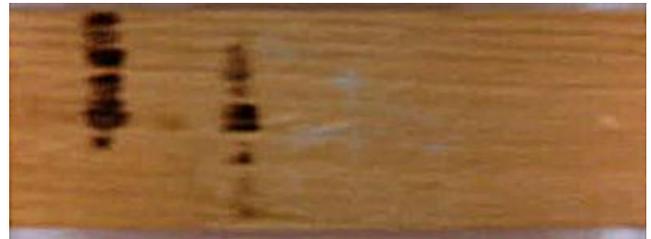
Figure 6. Surface with a cut burn.

We further inspected false negative and false positive detections. Majority of the false negatives were due to the location of the knots. As elements have thin and long surfaces, some partial knots were located on the edges and do not have circular shapes. Therefore, these knots are not detected by the system. On the other hand, false positives were primarily due to the friction burns

formed during the element cutting process (See Figure 6). In addition, factors such as crack, split, which add depth to the surface, affect the color distribution, and these results lead to false knot detection.
