Turkish Journal of Engineering (TUJE)
Vol. 3, Issue 4, pp. 179-188, October 2019
ISSN 2587-1366, Turkey
DOI: 10.31127/tuje.555268
Research Article

BEHAVIOR OF R/C FRAMES WITH CONCRETE PLATE BONDED INFILLS

Mehmet Baran *¹

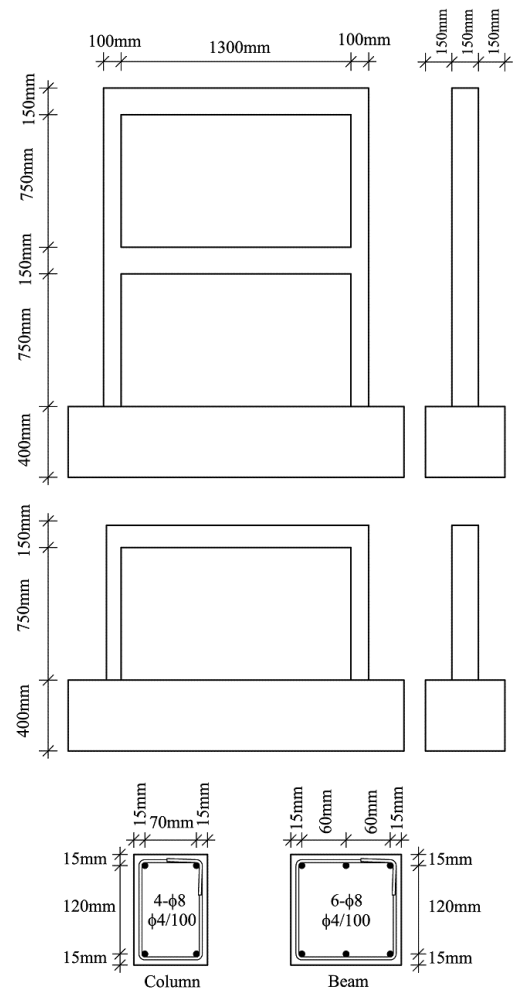
Fig. 1. Dimension and reinforcement of frames

One-third scale, one-bay, one-storey and two-storey RC frames with common structural deficiencies observed in real practice in Turkey were used as test frames. Such deficiencies are insufficient lateral stiffness, non-ductile members, bad detailing and low concrete quality. Dimensions and reinforcement of the test frames are illustrated in Fig. 1.

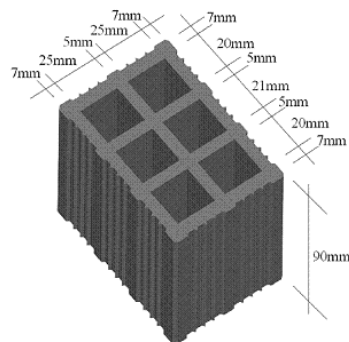
Fig. 2. Hollow Brick Dimensions

covered with scaled layer of plaster at both faces. Ordinary cement-lime mortar with ordinary workmanship was used during the plaster application and wall construction, reflecting the usual practice. The hollow bricks used in this study is illustrated in Fig. 2.

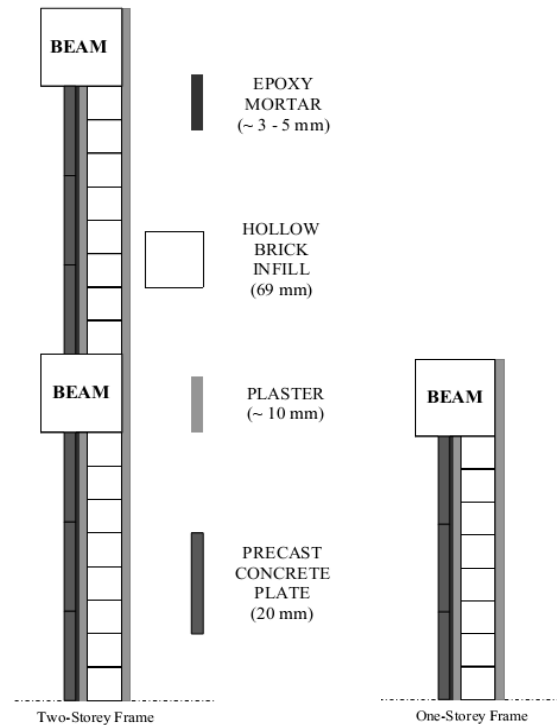
Fig. 3. Plate Bonding Method

Within the study reported, three different types of PC plates having two basic shapes were designed and tested to observe their performances as infill wall strengthening elements. One approach was to have rectangular shaped plates by arranging them in three rows and four columns, and another was to have full height strip shaped plates by using the full height of the infill in several lines. Plate thickness for all types was chosen as 20 mm. Therefore, the plates came out to be about 3 kg in weight. This weight is for one-third scale plates, so the corresponding weight for the actual sized plates would be about 80 kg, which is not too heavy to be carried manually by two workers. The plates "I" and "III" have nearly square geometry whereas the plate "II" has full height strip geometry. The method of bonding plates on to infill is illustrated in Fig. 3.

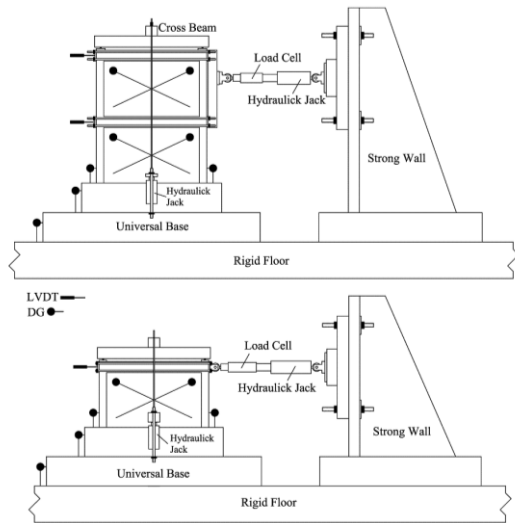
As it can be seen in Fig. 4, the setup consists of a universal base, test specimen, loading system and a reaction wall. The main foundation was fixed to the strong floor and the specimens were fixed on top of the main foundation by steel bolts.

Fig. 4. Test Set-ups and Instrumentation

In order to record deformations, linear variable displacement transducers (LVDT) and dial gauge type measurement devices were used. The positions of the gauges are shown in Fig. 4. The lateral load was being recorded by a load cell throughout the tests.

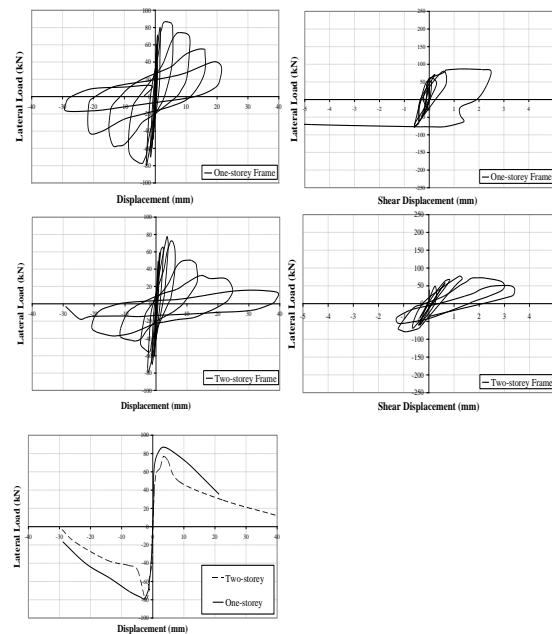
Fig. 5. Comparison of Lateral Load vs. First Storey Displacements of both CR Specimens

and two-storey frames had lateral load capacities of 79.1 kN and 78.8 kN, respectively. Corresponding first story drift ratio values at the maximum backward load were 0.0033 and 0.0030 for one-storey and two-storey CR frames respectively. Both frames exhibited typical masonry infilled frame behavior. The plastered hollow brick infill considerably contributed to the lateral load capacity at the initial stage, however, this contribution decreased rapidly as crushing started in the infill leading to a behavior similar to that of the bare frame where significant deformations took place under rather small lateral loads. The closeness of the capacity and corresponding first storey drift ratio values can be observed in the comparison of load-displacement curves and comparison of response envelopes, as shown in Fig. 5.

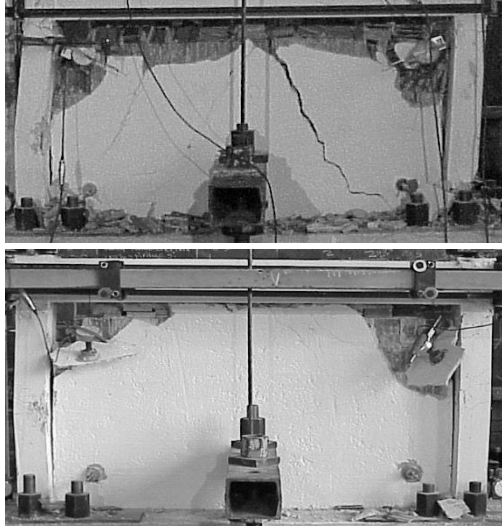
Fig. 6. Photographs of first storey infills (CR Specimens)

In the tests, diagonal cracking started earlier on the first storey infill of the two-storey frame than that of the one-storey frame. First hairline cracks on columns were observed together with the cracks on the infill at a lateral load capacity of 50 kN. This situation was observed in the test of one-storey frame at a lateral load capacity of 80 kN. For both frame types, infill started crushing from the corners and the lateral load started to be carried by the frame members. Transformation of behavior into bare frame action occurred about the eighth cycle for both frames, at a lateral load capacity of nearly 60 kN, where half cycle loadings were controlled by the top storey level displacement. The behavior was very similar considering the first stories and the failure of the frames occurred by crushing at column bases. Photographs of both first storey infills of both reference frames are given in Fig. 6., where the upper one is of two-storey frame and the lower is one-storey.

Lateral load-first storey shear displacement curves of all specimens are presented in Fig. 6, Fig. 9, Fig. 12 and Fig. 15. As seen in these figures, there was a visible shear deformation on the first storey of Reference Specimens CR. After introducing PC plates, the shear deformation due to base shear reduced in first storey plates. PC plates behaved rigidly so that they prevented excessive shear deformations. In the case of comparing the equivalent

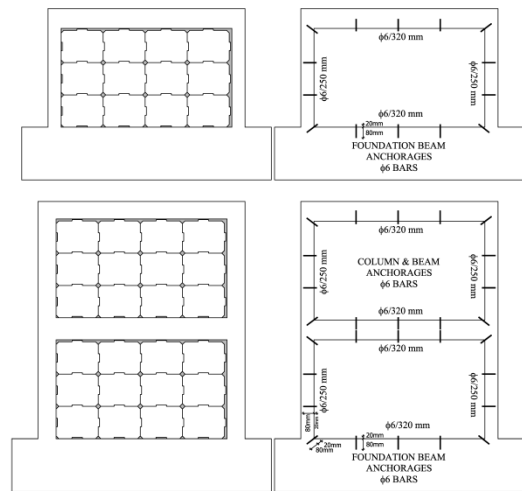
Fig. 7. Plate Arrangement for both CI Specimens

Both CI Specimens were strengthened by using Type I PC plates. The plate arrangement for both CI specimens is shown in Fig. 7. The lateral load capacities cannot be considered as close values since they were 209.6 kN and 186.2 kN for one-storey and two-storey frames, respectively. However, they were especially close for negative direction, which were 196.0 kN and 192.5 kN, respectively for one-storey and two-storey frames. For forward loading, first storey drift ratio values at the maximum load were 0.0120 and 0.0037, respectively for one-storey and two-storey frames. These ratios were 0.0038 and 0.0069 for backward loading. During testing of two-storey CI specimen, the entire test unit behaved nearly as a monolithic cantilever where failure took place at the base level in terms of yielding of the steel in the tension side column and concrete crushing and buckling of longitudinal steel in the compression side column. However, at the end of one-storey frame test, it was observed that some damage occurred in the infill; however, eventual exhaustion came with the failure of columns.

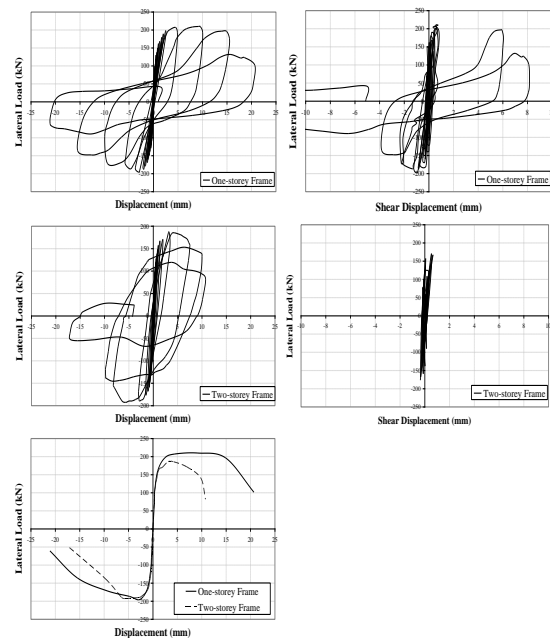
Fig. 8. Comparison of Lateral Load vs. First Storey Displacements of both CI Specimens

For both frames, the proposed technique led to a significant increase in the capacity and thus to a significantly better seismic performance meaning an effective behavior of plate strengthened hollow brick infill. In addition, one storey frame had more ductility as can be observed from the comparison of envelope curves given in Fig. 8. The difference in ductility is significant in the forward direction, but it does not seem to be much different in the backward direction. One-storey test frame have an envelope curve which is more wider, possibly caused by the pinching effect resulting from the large cracks developed on the infills. The more wider loops of one-storey specimen can easily be seen in the lateral load-top displacement graph given in Fig. 8. Photographs of both first storey infills of both specimens are given in Fig. 9, where the upper one is of two-storey frame and the lower is one-storey.

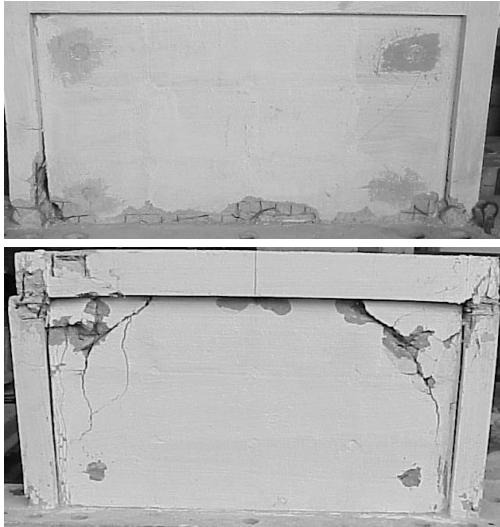
Fig.9. Photographs of first storey infills (CI Specimens)

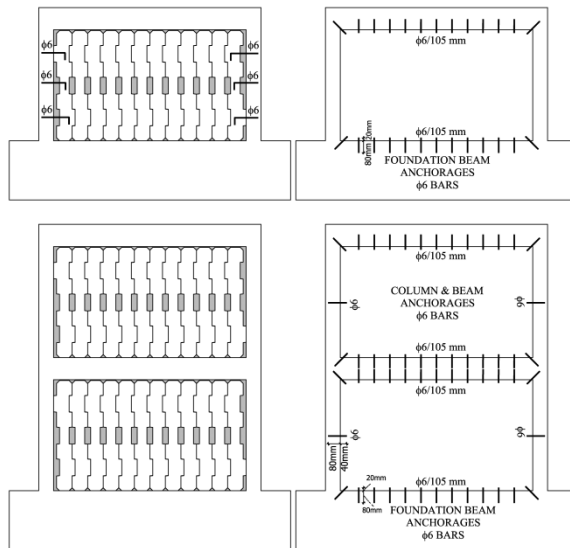
Fig. 10. Plate Arrangement for both CII Specimens

One or two storey frames strengthened with Type II plates were denoted as CII. The plate arrangement for both CII specimens is shown in Fig. 10. When the values in Table 2 are observed, it can clearly be seen that both types of frames showed significantly similar behavior for both loading directions in the perspective of lateral load capacity and response envelopes. One-storey and two-storey CII specimens reached lateral load capacities of 197.0 kN and 201.3 kN, respectively for forward loading and 187.4 kN and 198.2 kN, respectively for backward loading. Corresponding first storey drift ratio values were 0.0056 and 0.0089, respectively for one-storey and two-storey test frames for forward loading and 0.0066 and 0.0070, respectively for backward loading. The response

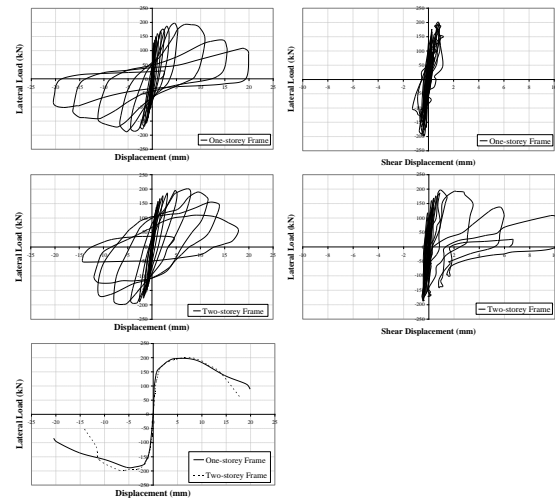
Fig. 11. Comparison of Lateral Load vs. First Storey Displacements of both CII Specimens

envelopes seem to be almost coinciding with each other. There is some difference between the curve shapes in the load-deformation plots of two frame types. As in the cases of both CI specimen tests, the entire two-storey specimen CII behaved nearly as a monolithic cantilever whereas it was observed that some damage occurred in the infill of the one-storey specimen CII. As compared to one-storey CI Specimen, this specimen has less narrow cracks and hence, less pinching effect most possibly stemming from this phenomenon. Lateral load-top displacement graphs for both specimens are given in Fig. 11.

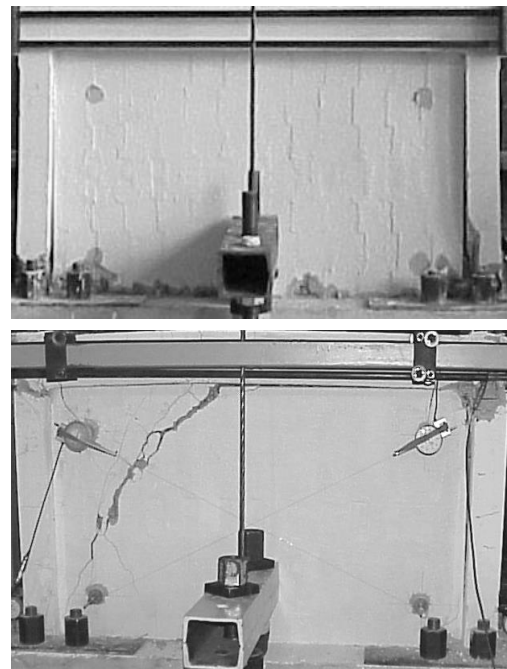
Fig.12. Photographs of first storey infills (CII Specimens)

cracking. At the one-storey frame, plate cracking started at later cycles, and the infill was separated from the frame. The two tests ended similarly by damages in the column bases, but the one-storey frame had much greater damage at the joint region whereas two-storey frame had greater damage at the base level. Test results for both frame types are given in Table 2. Photographs of both first story infills of both specimens are given in Fig. 12, where the upper one is of two-storey frame and the lower one is one-storey.

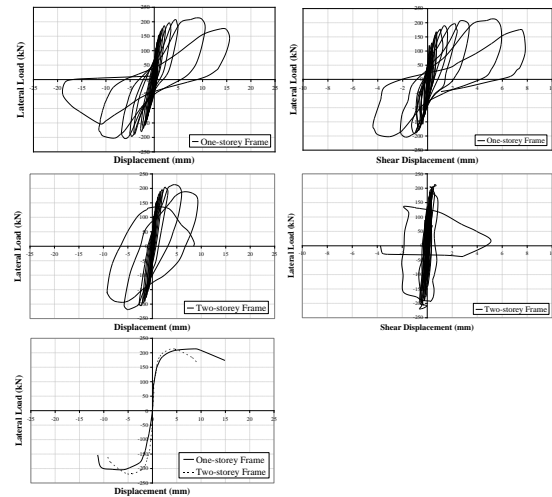
Fig. 14. Comparison of Lateral Load vs. First Storey Displacements of both CIII Specimens

frames with anchorage to all frame members in the first storey. The plate arrangement for both CIII specimens is shown in Fig. 13. Two frame types showed similar response as can be observed from the values given in Table 2 and response envelopes given in Fig. 14. For forward loading, one storey and two-storey test frames reached a lateral load capacity of 213.5 kN and 212.9 kN when the first storey drift ratio values were 0.0103 and 0.0055, respectively. For backward loading, they reached maximum load values of 204.0 kN and 218.5 kN at drift ratios of 0.0071 and 0.0062, respectively. One-storey specimen has higher ductility than the two-storey specimen, especially in the positive direction. In the negative direction, maximum lateral displacement of two specimen types seems to be similar. It can be noted here that, one-storey specimen has a little wider response envelope than the equivalent two-storey specimen which can possibly be attributed to the pinching effect stemming from the cracks occurred on the infill of the one-storey specimen.

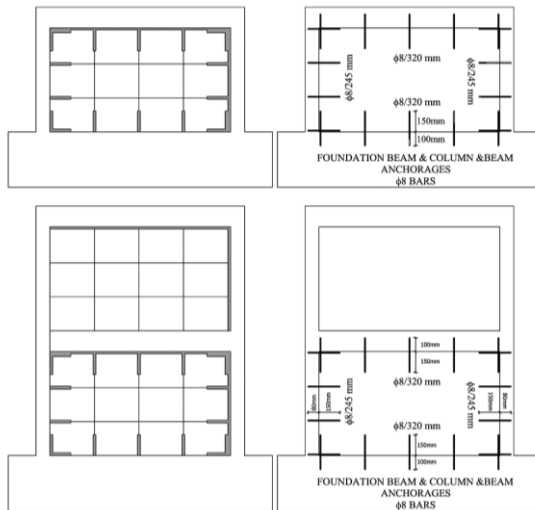
Fig. 13 . Plate Arrangement for both CIII Specimens

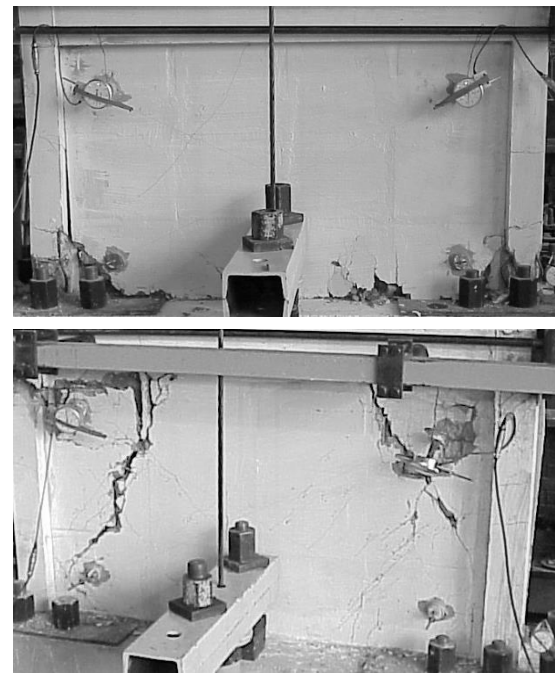
Fig. 15. Photographs of first storey infills (CIII Specimens)

Separation of the infill from the columns and cracking at the column bases started in early cycles of both tests. Also, diagonal cracking on the plates started at the same load level for both cases. However, beam-column joints cracked at the one-storey frame before plate cracking, but at the two-storey frame, beam-column joint cracks occurred after plates started cracking. In the last cycles of both tests, column bases started to crush and the cover concrete dispersed. The two-storey frame failed from the column base crushing. On the other hand, the one-storey frame, also having significant damage at the column bases, failed by crushing at the beam-column joint suddenly. One-storey frame had much more wider cracks on the plates. Test results for both frame types are given in Table 2. Photographs of both first story infills of both specimens are given in Fig. 15, where the upper one is of two-storey frame and the lower is one-storey.
