Fig. 1: Site plan of Sardis.

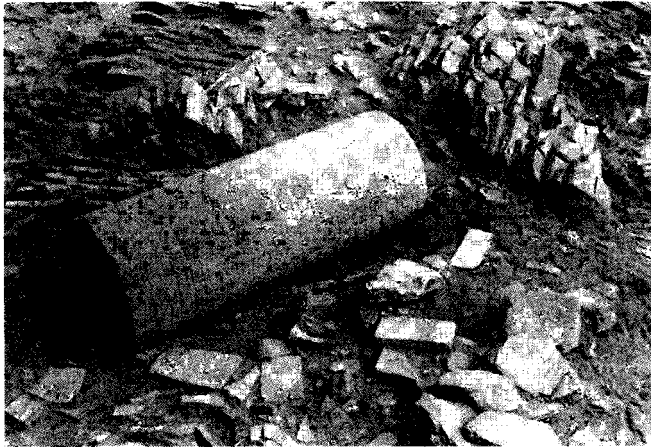
Fig. 15: Sector MMS-N: Roman avenue, destruction debris in south ambulatory with inscribed marble cylinder, IN79.8.
