Developing Mechanical Harvesting for California “Black Ripe” Table Olives (*Olea europaea* cv. “Manzanillo”)

Abstract: The *Olea europaea* cv. “Manzanillo” fruits destined for “California Black Ripe” table olive processing are harvested before fully mature where fruit detachment forces are over 5.0 N. Superficial bruises that has not extended into the flesh, are masked by the processing methods as the immature fruit is oxidized to black during processing. A jatropa canopy contact harvester was modified to adapt the density and length of the radiating rods to extend into the 1.0 m olive canopy depth. Preliminary studies determined a head speed of 300 rpm, a displacement of 125 mm and a tine length of 910 mm are the most suitable parameters for table olive harvest. In the first of two field experiments, a 19 year old 4x8 m hedgerow orchard mechanically pruned with a production of 18.5 ton/ha was harvested with 92% average efficiency versus 81% of efficiency for a hand pruned conventional control orchard with a production of 32.58 ton/ha.

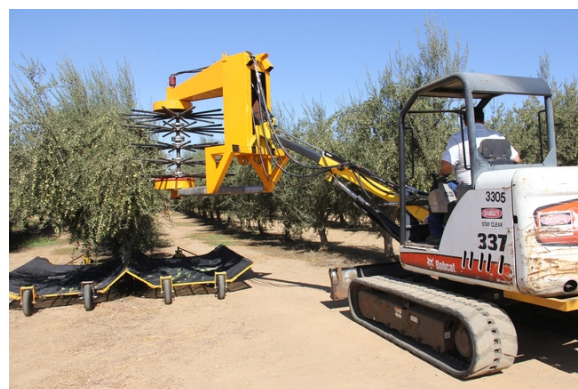
Figure 1. Experimental olive shaker (EOS)

As shown in Figure 1, the shaking head was mounted on a track laying tractor (Bobcat 337G Excavator). This rubber tracked machine provides a stable base for the shaking head as well as the control

system for moving and powering the head. The conventional boom was removed and replaced by a short telescoping boom. The main lift cylinder from the standard boom was retained to lift the telescoping boom. The control which moved the bucket on the standard boom now is used to tip the head forward and back. The auxiliary power circuit provides the hydraulic fluid to the hydraulic motor which now powers the shaker.

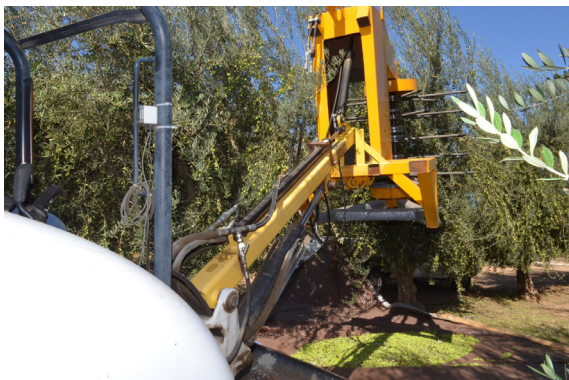
The telescoping boom was partially raised and partially extended. The telescoping function is controlled by the 1220x25 mm hydraulic cylinder which is located on top of the boom. The 610x25 mm tilt cylinder is attached near the end of the boom and is connected to a pivot point near the top of the "C" frame.

Figure 2. EOS from the right side of the Bobcat excavator

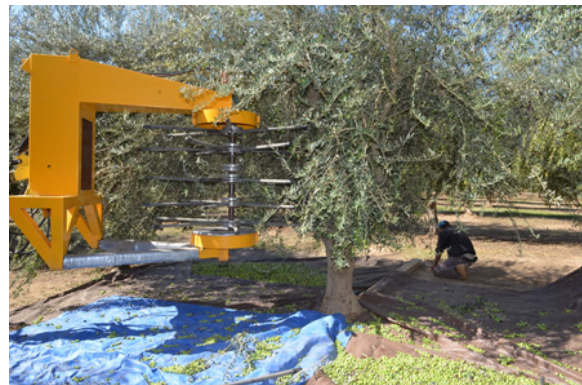
The shaker head has a counter balanced vertical crank turning in a substantial "C" frame. A hydraulic motor has been placed at the top of the crank mechanism. A pair of bearings at the top and bottom of the crank provide the center about which the crank turns (This is conceptually similar to the crank shaft in

Figure 3. The "C" frame which holds the crank

This machine was designed for another crop (Jathropha). Major modification or redesign should be done on this machine for olive harvesting. The bulky design irritated the operator due to the difficulty of locating the shaking head. The "C" shape frame has a 1500 mm opening, and could accommodate rods of 1220 mm long. The rod breakage could be reduced by shortening the rods to 910 mm, and this does not reduce our ability to remove fruit from the trees. Whereas, a smaller C frame designed to use with 910 mm rods could improve visibility of the operator, reduce the weight of the shaking head, and perhaps even eliminate the need for a counter balance on the Bobcat.

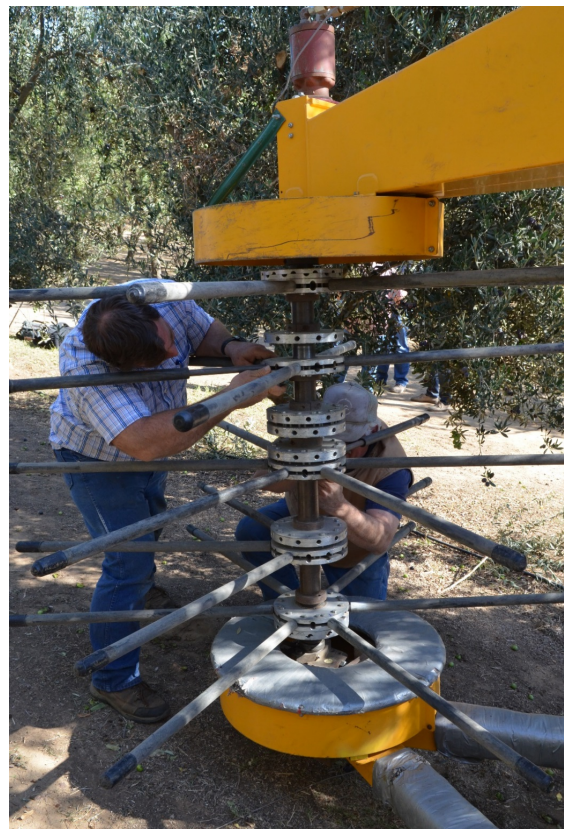
a single cylinder engine. Instead of a piston attached to a counter balanced crank, it was a set of rods attached to the crank). On this machine, the displacement of the center of the crank can be varied in 13 mm increments, and the displacement of the counter balances are also variable to compensate for the weight and offset of the crank. A shaft (25.4 mm diameter) connects the top and bottom of the crank. A steel sleeve (65 mm diameter) is connected to this shaft by bearings so that the sleeve is free to rotate independent of the internal drive shaft.

Figure 4. The crank mounted in the "C" frame

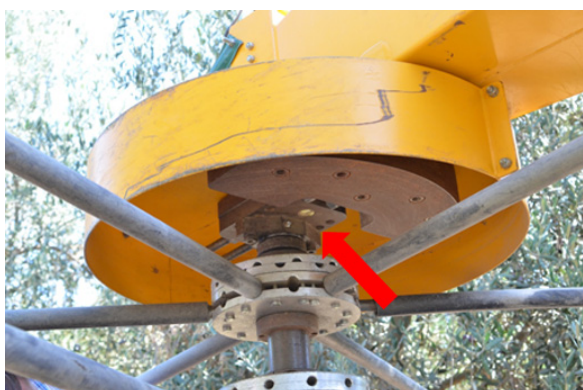
Figure 5. The top of the crank

In the Figure 5, the small yellow spot has shown the center of rotation. The crank is offset in one direction, and the counter balance is offset in the other direction. It can be also seen the two part aluminum rod holders which clamp together to hold the rods in place.

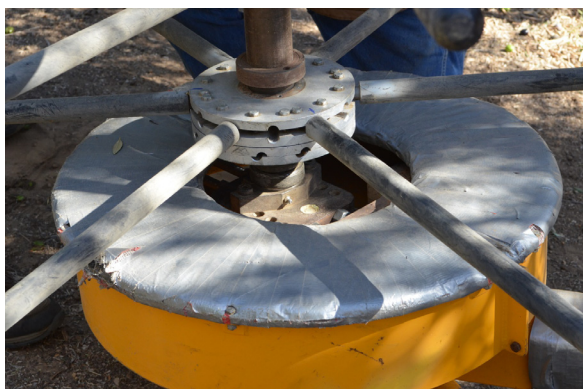
Figure 6. The bottom of the crank

The bottom of the crank is identical to the top except that it is mostly covered to keep fruit from being damaged by the mechanism.

There is no motor on the bottom. The bottom of the crank shaft rides on a brass plate, which is held in place by a steel plate.

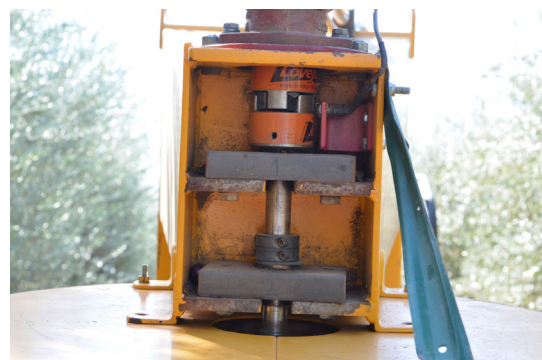
A hydraulic motor sits on top of the "C" frame and is attached to a Lovejoy coupling, which is, in turn, attached to the top of the crank. Two steel mounted brass bearings hold the top of the crank in alignment.

Figure 7. Hydraulic motor

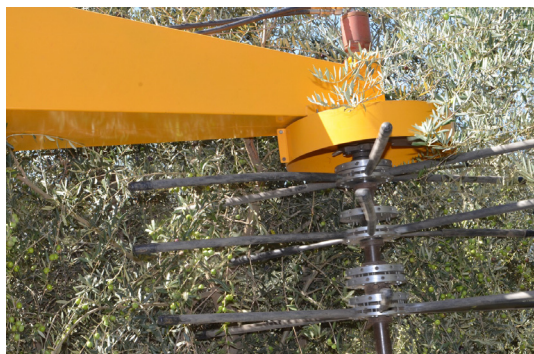
Figure 8. The shaking head presses into the tree compressing the canopy

When the foliage hangs freely and is not compressed, very little fruit is removed by the rods. By compressing the foliage, the vibration is transmitted to the fruit causing the olives to separate from the tree. Compressing the foliage can have the negative effect of forcing rods into contact with larger limbs, resulting in broken rods.

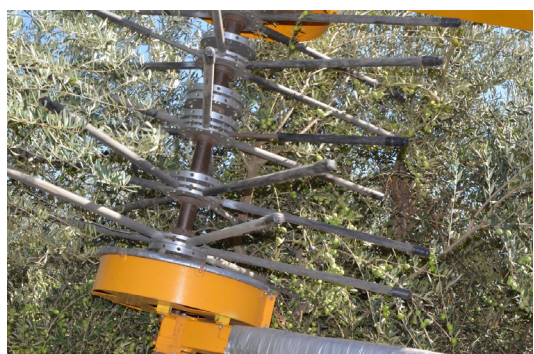
Figure 9. The interaction between the tines and larger limbs
