AMBIENT VIBRATION ANALYSIS of an INDUSTRIAL BUILDING

Abstract: Due to the heavy and dynamic equipment, the vibration and resonance effects that are not encountered under static dead loading may amplify over time in industrial buildings. This might cause damage to the structural system and create human comfort problems while the structure is in service. In this study, ambient vibration testing of a building composed of reinforced concrete and steel structural systems and located at a boron processing plant in Turkey was performed. The velocities and accelerations caused by the sieve shaker system attached to the structure with springs, are evaluated under the effect of sample loading.

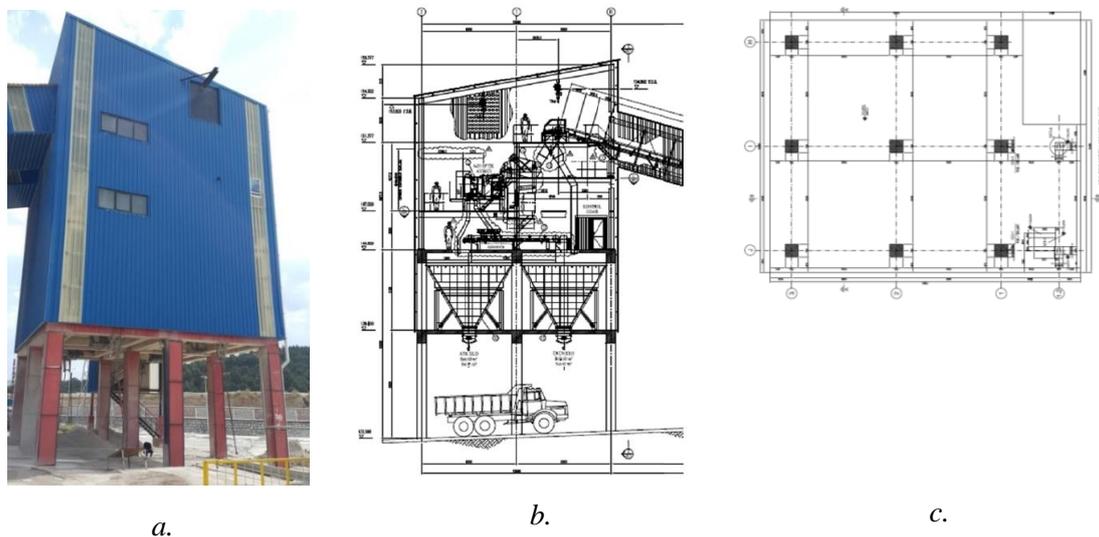
Figure 1:
Optical Separator Building floor plan and cross section
a. 3-D view of building **b.** Cross section of building **c.** Floor plan of building

The building is a steel structure with two floors of reinforced concrete frames as shown in Figure 1. The reinforced concrete part of the main building is symmetrical in the plan. Axle ranges are 6.00 meters. The two-floor reinforced concrete building is designed with high ductility level. There are no irregularities (A1-A2-A3/B1-B2-B3) in the reinforced concrete part of the building, mentioned in the Turkish Building Earthquake Code (TBEC 2018). The anticipated characteristic concrete compressive strength (f_{ck}) of the building is 25 N/mm^2 and characteristic reinforcement strength (f_{yk}) is 420 N/mm^2 . The main beams of floors are $600/750 \text{ mm}$ and $750/750 \text{ mm}$, and the intermediate beams are $400/600 \text{ mm}$ and $500/600 \text{ mm}$. The main columns in the optical separator building are $750/750 \text{ mm}$. Floor thickness is 200 mm . No damage could be detected in the structural system of the building as of the date of the examination by the authors, and no visible corrosion has been observed in the steel elements in particular.

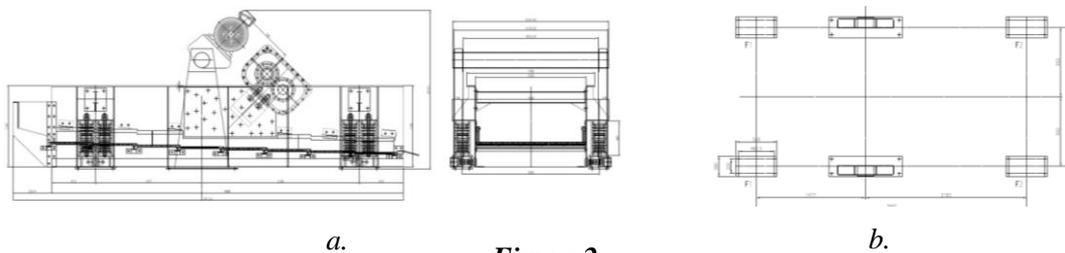
Figure 2:
Sieve system
a. Cross sections of sieve system **b.** Plan of sieve system

The sieve system in the steel part of the structure, shown in Figure 2 and Figure 3, is 1.90 m x 3.66 m x 2.21 m. The sieve system has been tested for various loading conditions. In the measurements, the vibration values of the upper and lower parts of springs are measured. Nine Piezoelectric type accelerometers (PCB Piezotronics brand, 393B04 model) are used in the measurements (Figure 4-7). The sensitivity, measurement range and frequency range of the accelerometers are 1.0 V/g, ± 5 g and (0.06 to 450 Hz), respectively. Accelerometer mounting studs were fixed to the structure using a polyester resin-based adhesive, and then accelerometers were screwed into the studs. Piezoelectric accelerometers are used in various measuring applications, from very low frequency seismic applications to multiplication tests that require a very high frequency linear operating range. These transducers are small sized, may work in high temperatures and have industrial standard enclosures.

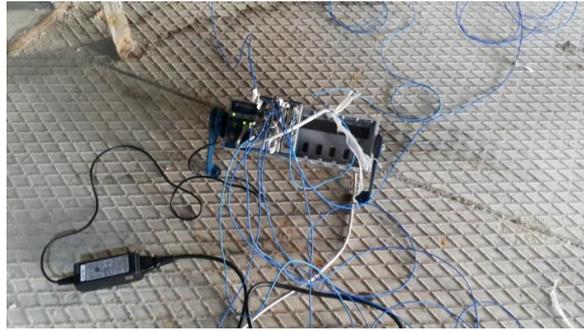
Figure 5:
Data collection system

The accelerometer data were acquired using National Instruments Compact Data Acquisition system through NI 9234 modules. The acceleration, velocity and displacement histories are analyzed in both time domain and frequency domain by analyzing these acceleration-time values (Figure 3-4 and 5).

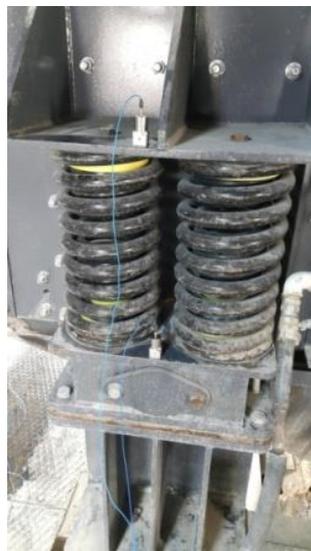
Figure 6:
Accelerometers placed on the springs under sieve

Accelerometers are used under and above the vertical springs where the sieves are placed. In addition, an accelerometer is placed on the steel profile on which the sieve motor sits (Figure 6 and Figure 8). Vibrations are measured at a total of 9 ($a_1 - a_9$) points and the direction and positions of the accelerometers are shown in Figure 8. The frequency-acceleration response graphs are obtained for 10 measurements at indicated locations. As a sample, frequency-acceleration response graph for measurement no 1 at location no 5 is shown in Figure 9. Vibration acceleration amplitude was determined as RMS (Root Mean Square) or m/s^2 as the square root of averages. Peak values can be obtained by multiplying the values in the graphs by 1.41. In the experiments, different evaluations were made according to the direction of the springs under the sieves and loading type. These evaluations are shown in Table 5.

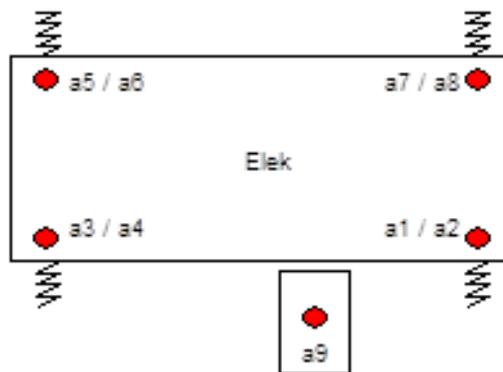
Figure 8:
Direction and position of the accelerometers

A total of 9 different acceleration measurements (Fig. 8) were made in the motor cell located next to the sieve and in springs on which the sieves are placed. According to the evaluations, the critical values for the condition where sieve and sub-vibrator work together are given in Table 6. In addition, a sample loading and the obtained acceleration value are given in Figure 9. Among these values, it is observed that the speed values, especially between 170 mm/s - 296 mm/s, are decreased by 10 times to 17 mm/s - 30 mm/s. A similar situation exists for amplitude and strength, even at different rates. This also shows the damping properties of the springs. Here, the measurements taken under the springs are related to structure. Because the effects on the structure are related to these values. The high damping capacities of springs are evaluated positively, but the vibration frequencies of springs under load are considered to be a problem because the high amplitude values of the structure overlap with any natural vibration frequency.

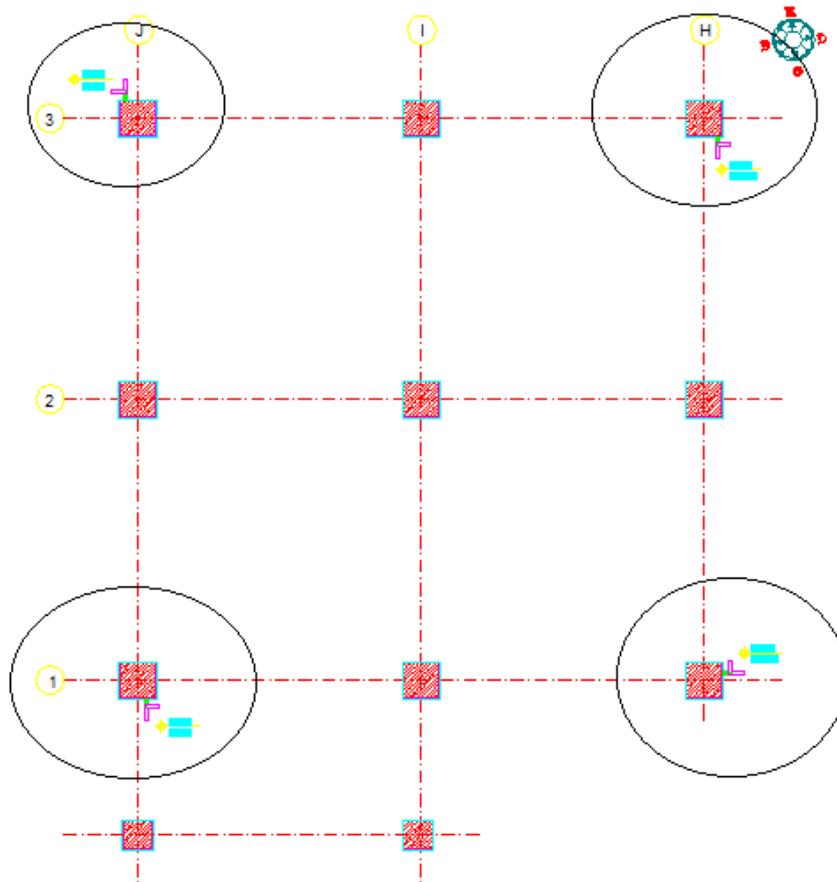
Figure 10:
Direction and position of the accelerometers

Figure 10 shows the direction and positions of the accelerometers placed in reinforced concrete section. Accelerometers are placed in upper and lower levels of corner columns in the floor plan. The accelerometer at the lower floor is located 500 mm above the natural ground level. The accelerometer at the upper level is located in areas close to the column-beam joint. The vibration velocity and acceleration amplitude given for the respective points are peak values and are determined as mm/s and m/s^2 respectively. Figure 11 shows these values. The harmonic frequency was detected as 15.73 Hz for this case. In the measurements given in the figures, loading is applied for sieve and under-sieve vibrator operation.

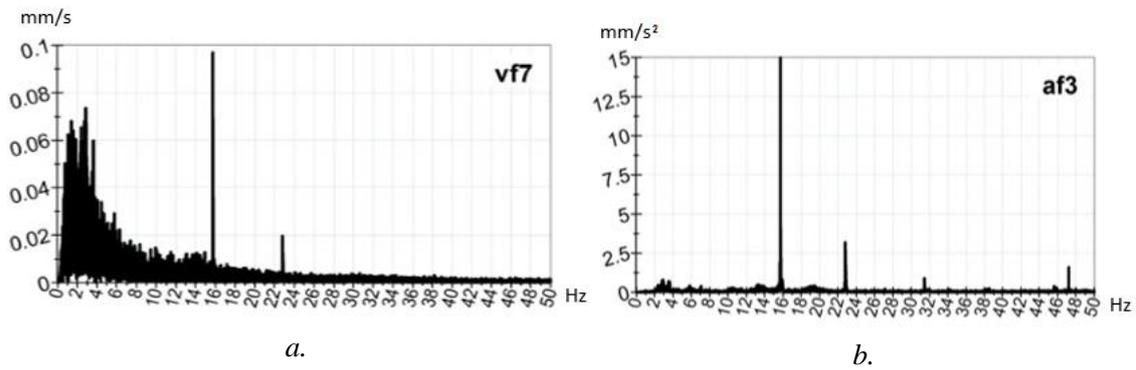
Figure 11:

Critical speed (mm/s) – Frequency and acceleration (mm/s²)- Frequency speed in reinforced concrete columns at J1 and H3 axes in X direction.

a. Critical speed (mm/s) – Frequency b. Acceleration (mm/s²)- Frequency

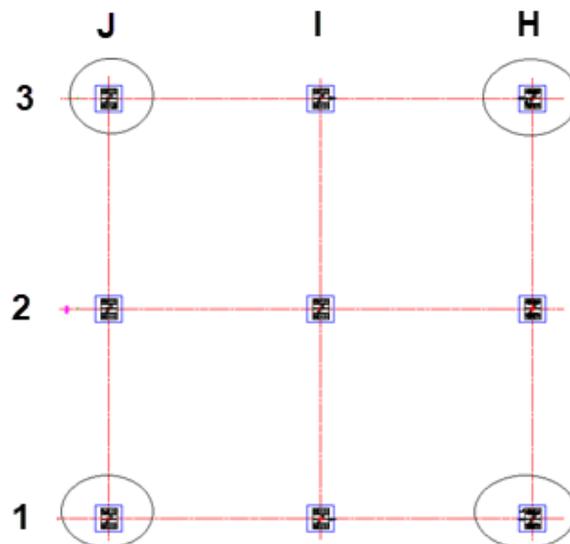
Figure 12:

For the steel part of the structure, three measurements were made separately and a single acceleration meter was used in the last layer of the building. The other accelerometer is positioned at four corners for each floor in the column beam joints (in areas as close as possible to floor alignments). Thus, the measurement was completed with nine accelerometers to determine the dynamic properties of the structure. By frequency processing of the obtained recordings, in other words, by transferring the time domain records to the frequency domain by Fourier Transform, dominant frequencies of each measurement were obtained. The frequency-amplitude graphs of the vibration displacements and accelerations were drawn from the measurements made in two directions from 8 different points. The graphs given below are for the orientation and direction of each measurement, respectively (Figure 12-14). In addition, the positions and directions of the accelerometers are given in Table 8. Figure 12-14 shows the locations of the accelerometers, and the speed-frequency and acceleration-frequency values obtained are shown in Figure 15-16. The harmonic frequency was detected as 22.48 Hz for this case.

Direction and position of the accelerometers

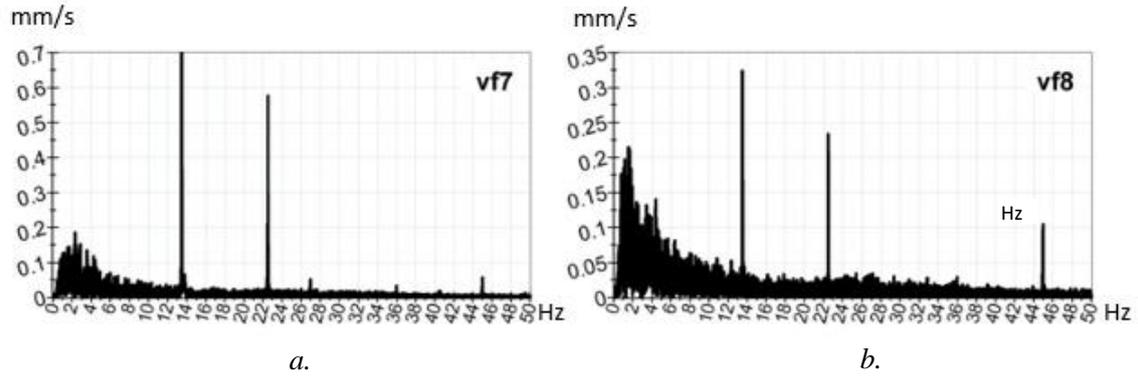
Figure 15:
Speed (mm/s) at corresponding points in steel columns - Frequency values at H1 axis in X and Y directions.

a. Speed (mm/s) - Frequency in X direction **b.** Speed (mm/s) - Frequency in Y direction

The velocity and acceleration values obtained from the reinforced concrete columns and the velocity and acceleration values obtained from the steel system (Figure 15 and Figure 16), are quite different from each other. However, velocity amplitudes below the limit of damage are determined according to the values obtained from the columns. This can be interpreted as the fact that the vibration felt on the columns and which become more translucent with local resonances will not have a significant effect on the columns of the structural system.

- Due to the fact that the structure will be used continuously with these measured vibrations, especially in the steel part will suffer from material fatigue over time and the increase in speed and acceleration components of the vibration response is expected. It is also appropriate to check the conveyor system and the machine tool part of such structures at certain intervals. For this, six-month periods can be determined.
