Çomakdağ-Kızılağaç Village Houses in the Context of Rural Architectural Building Traditions That are Vanishing in Our Country

Can Mehmet HERSEK^{1,*}

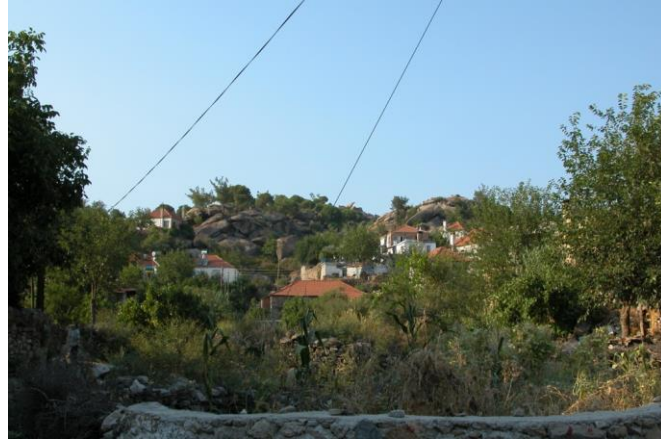
Figure 1. Çomakdağ-Kızılağaç Village Settlement which is formed by separate buildings and building groups placed on terraces on rocky and rugged slopes (photo belongs to the author)

The general characteristic structure of the Çomakdağ range has been eroded by the effects of heavy rainfall, sun and wind and has become rounded with soft lines. The settlement patterns in the region are natural settlements that have settled within this structure without disturbing it and using it. The village coffee house, shaded by large mulberry trees in the square of the village, which is reached by climbing a narrow two-lane road, forms the center of the settlement. The mosque of the village was also built in this relatively flat area. In Kızılağaç-Çomakdağ, the houses that form the main settlement texture are located on a rocky hill surrounded by olive trees. These houses of the village are constructed at the most suitable points of the hilly terrain and are in the form of stone and concrete structures with courtyards, gardens and huge rocks that form the borders of the streets that have developed organically without any geometrical features. On the pedestrian paths, Çomakdağ stone texture is left in its natural state. In many places, many of the roads that do not allow motor vehicle transportation also end with dead ends. Houses are located as separate buildings and building groups placed on terraces on rocky and rugged slopes (Figure 1,2,3). We know that in the first stage of village development all the the buildings are made of stone and wood. Unfortunately many of these houses have lost their original features as a result of additions and alterations with inappropriate methods and materials. Also new structures which are made of concrete and bricks are increasing rapidly (Figure 4).

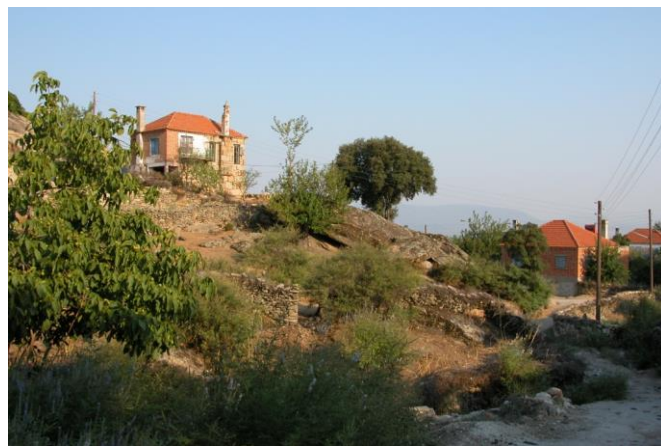
Figure 2. Houses are located as separate buildings and building groups placed on terraces on rocky and rugged slopes (photo belongs to the author)

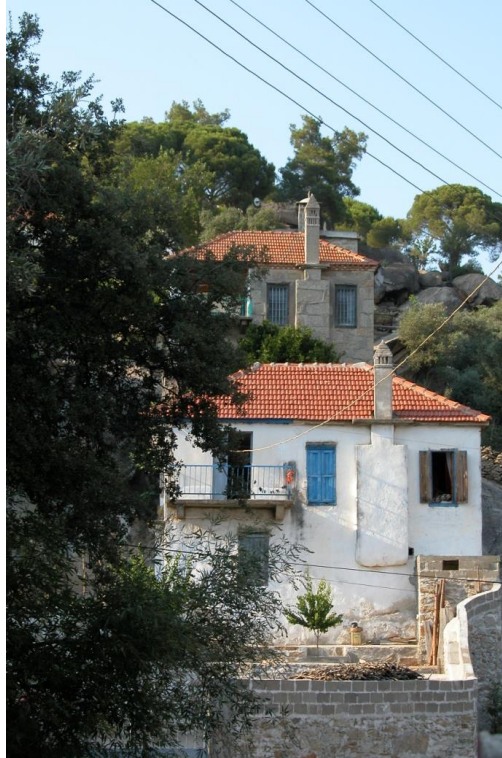
Figure 3. A traditional hanay type houses from Çomakdağ-Kızılağaç which preserves original features. (photo belongs to the author)

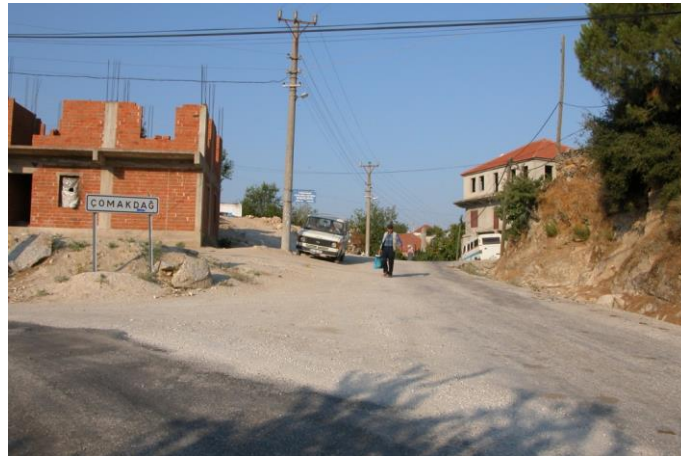
Figure 4. New constructions of Çomakdağ-Kızılağaç Village (photo belongs to the author)

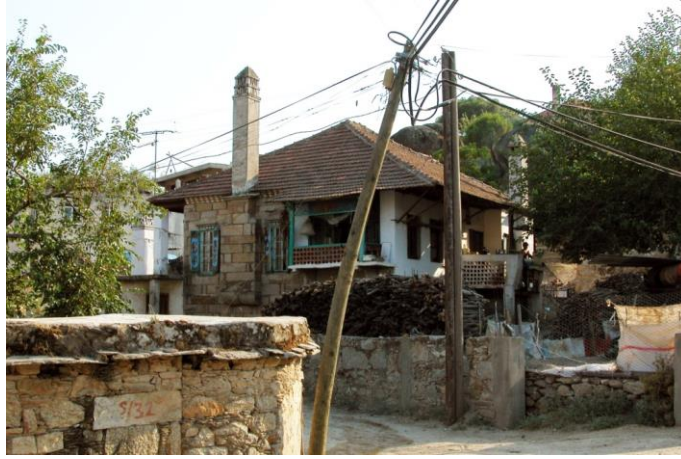
Figure 5. A house from Çomakdağ-Kızılağaç Village which has newly added roof. (photo belongs to the author)

In the Mediterranean Sea climate, it is important to orient the buildings according to the air breezes. However, it is just as important to prevent buildings from being affected by radiation [2]. Therefore the traditional houses in Kızılağaç-Çomakdağ are characterized by one or two storeys, surrounded by thick walls of cut stone, windows open to the view, exterior entrance with stairs, projecting fireplaces with windows on both sides, earthen flat roof (Presently many of them has new roofs with tiles) and most importantly the use of carved wooden ornaments (Figure 5).

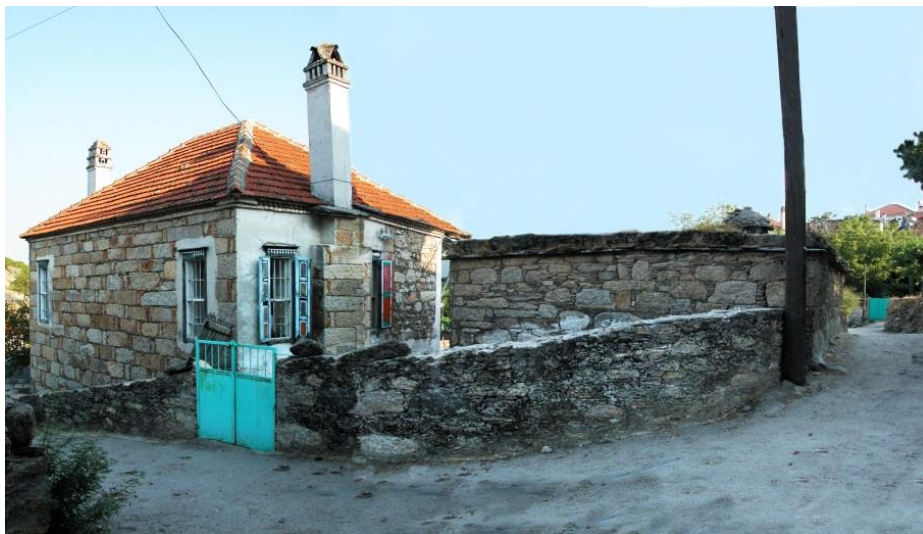
Figure 6. Neighbouring two houses from Çomakdağ-Kızılağaç Village, one is “yer evi” type and the other one is “hanay” type (photo belongs to the author)

These houses locally called as “yer evi” and “hanay” were built according to four different plan types [3,4]. The basic plan type is a building with a single room. The basic plan type is a one-room building. In this type of house, the room spaces are defined by wooden floor elements, the living area is built directly on the ground and the storage area is left bare without any cladding [3,4]. In the second plan type there is also one single square room which is raised from ground therefore the entrance of houses are more than one meter from the ground. The lower floor is used as a cellar or granary. The main domestic life takes place in the rooms on the upper floors. The other plan types of “hanay” are more developed structures with one or two or more rooms which were placed above the granaries and they have semi opened verandas called “ayazlık” [3]. These ayazlık’s are located on the south side of the two-storey houses facing the courtyard and at the street side they have a raised platform for sitting which is called “sekili köşk” with the sofas called “sedir”(Figure 6). The stairs that provide access to the living floor from the courtyards or gardens are also connected to this ayazlık section from the outside, and there is also a wooden bench called "suluk" in this space, which has the function of washing pots and pans (Figure 7). There are also wooden laticce works all around the “ayazlık” spaces. The wooden köşk keeps the entrance gate to the courtyard and the path leading to the house under control, and forms a breezy and open section surrounded by sofas where the lady of the house spends the summer months. Grains and dried food kept throughout the year in the breezy and cool living area “hayat”.

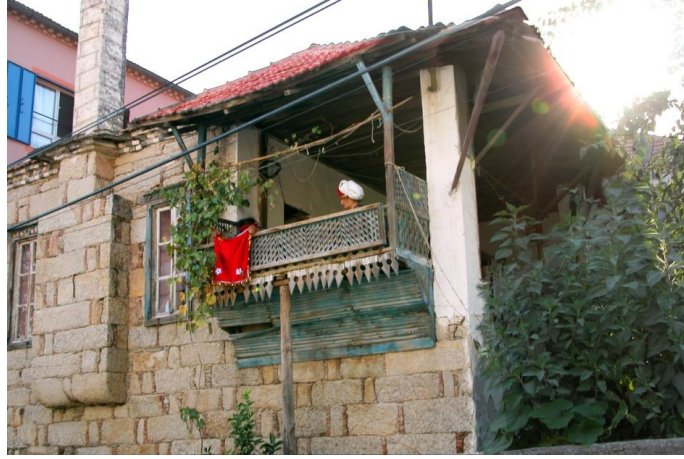
Figure 7. A ayazlık from Çomakdağ / Kızılağaç house “hanay” (photo belongs to the author)

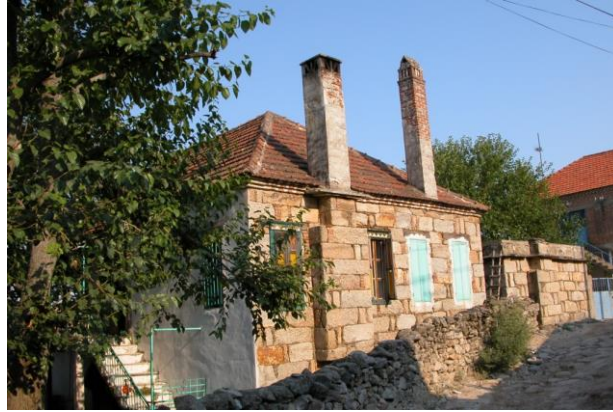
Figure 8. Window orders of a Çomakdağ / Kızılağaç house (photo belongs to the author)

As it is mentioned traditional Çomakdağ-Kızılağaç houses are made of stones quarried from the region. There are several original stone dwellings in the village, which have mostly preserved their original architectural features (Figure 8). Originally the buildings are made of large stones supplied from the quarry near the settlement; these stones, which are 30-50 cm wide and 50-120 cm long, are carried from the quarry to the building site on mule backs [3,5]. Two types of stone found in the region are used in the stone masonry are used together: the main stone blocks of the body walls between them a stone that is darker in color and thinner in texture that can be delaminated into thin layers (slate). The stones were carved smoothly on one side only and used on the exterior of the building. These large gnays stones, with a hub in the center, are built with stone blocks placed according to a specific binding system, placed according to the rhythm of wide joints along the facades of the building, leaving a margin of three or four wedge stones placed transversely between them [3,4]. These are rotationally aligned along the wall. Also there is a special technique that the use of these small fragments for filling joints and ornamentation is one of the last makes it extremely interesting. These wide joints between the chipped stones used on the facades of the buildings were filled with tile fragments. These joints between the stones are tightened with 15-20 cm. long, 5-8 cm. wide pieces made of broken olive pieces of oil potteries called nails (Figure 9, 10). This type of masonry technique is very similar to the Hellenistic masonry techniques seen in the ancient buildings at Labraunda settlement [3]. At the end of the arrangement of each horizontal row of stones along the walls of the building, the nails are fused with the adobe mortar poured in the center of the wall. The core of the stones crosses the middle of the wall width, so the center of gravity of the stones is shifted towards the middle of the wall. On the outer surfaces of the walls; this masonry is completed with rubble stone masonry covered with plaster made of lime mortar on the inner surfaces. The houses shine brightly in the sun due to the quartz, mica and feldspar substance of the gnays stone blocks and this stone material is keeping them cool

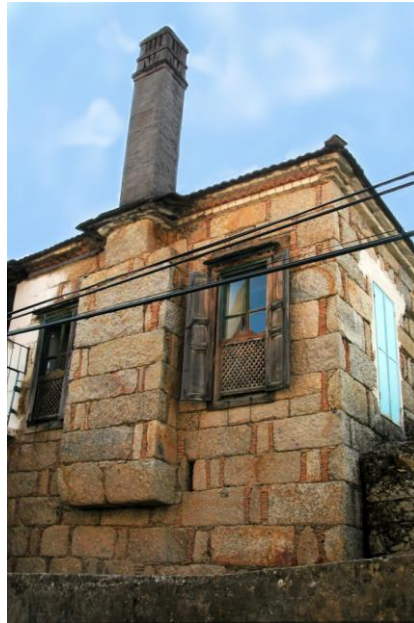
Figure 9. A general view of the stone wall of a house in Çomakdağ / Kızılağaç (photo by the author)

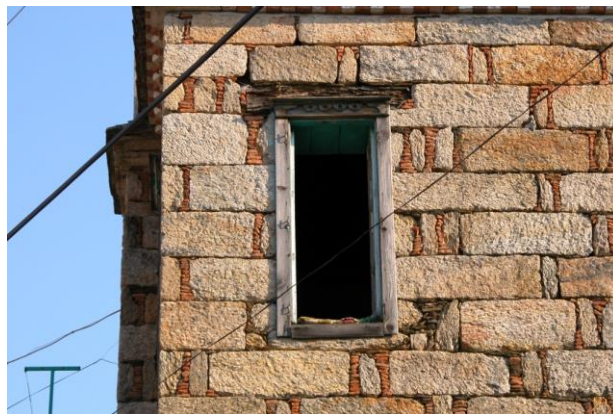
Figure 10. An example of stone masonry from Çomakdağ / Kızılağaç house (photo belongs to the author)

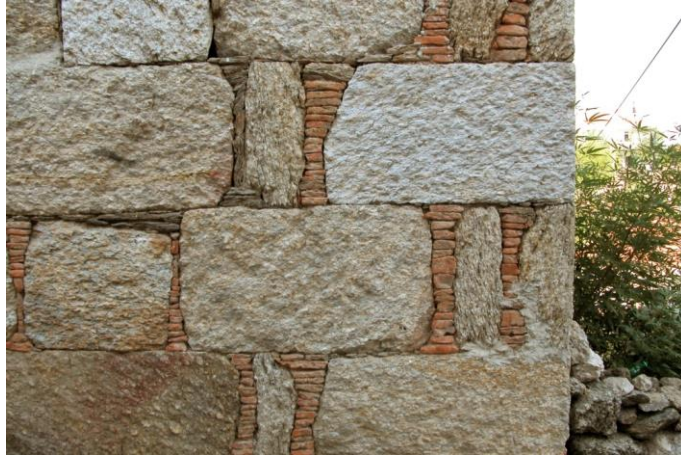
Figure 11. Details from stone masonry whith joints between the stones are tightened with 15-20 cm. long, 5-8 cm. wide pieces made of crushed olive oil potteries called nails Çomakdağ / Kızılağaç house (photo belongs to the author)

in summer and warm in winter. Reflecting the image of traditional housing, this compact buildings have a high impression value (Figure 11).

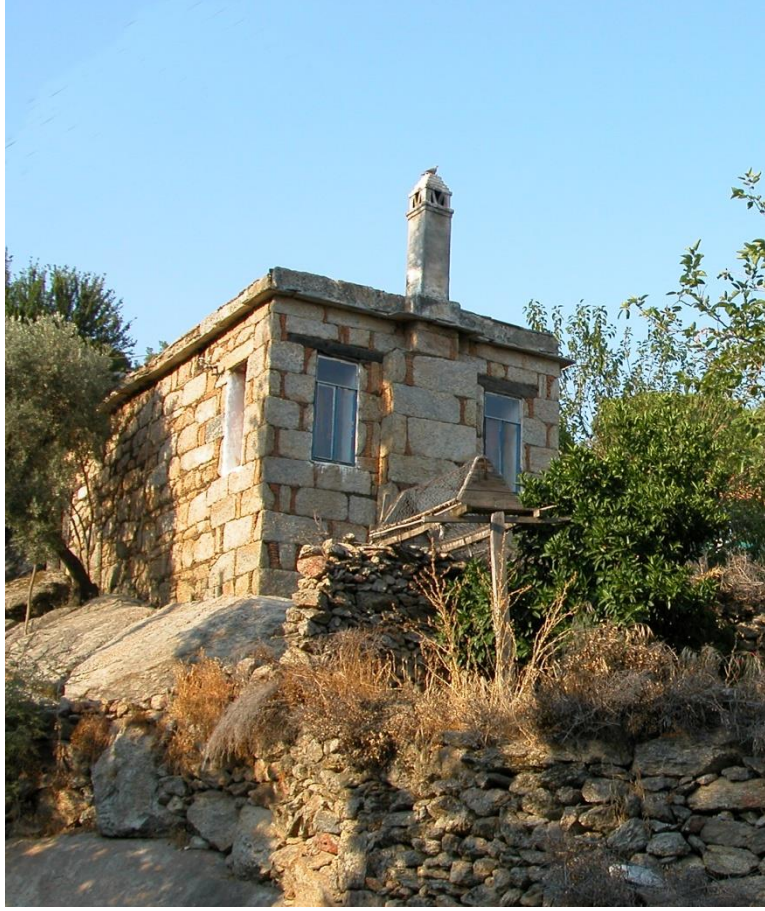
Figure 12. A traditional house from Çomakdağ / Kızılağaç which preserves original flat roof (photo belongs to the author)

As it is mentioned above stone walls of the traditional houses of the village were build with load-bearing masonry technique the floors in the structure are wooden and the upper cover is flat roof. Although today most of the buildings are covered with hipped roofs or some houses have an extra additional roof coverings over these roof structures. For this reason, the number of flat roofed buildings that have survived in their original form is quite low (Figure 12). The “ayazlık” is covered with a pitched roof and the roof is supported by wooden or stone pillars.

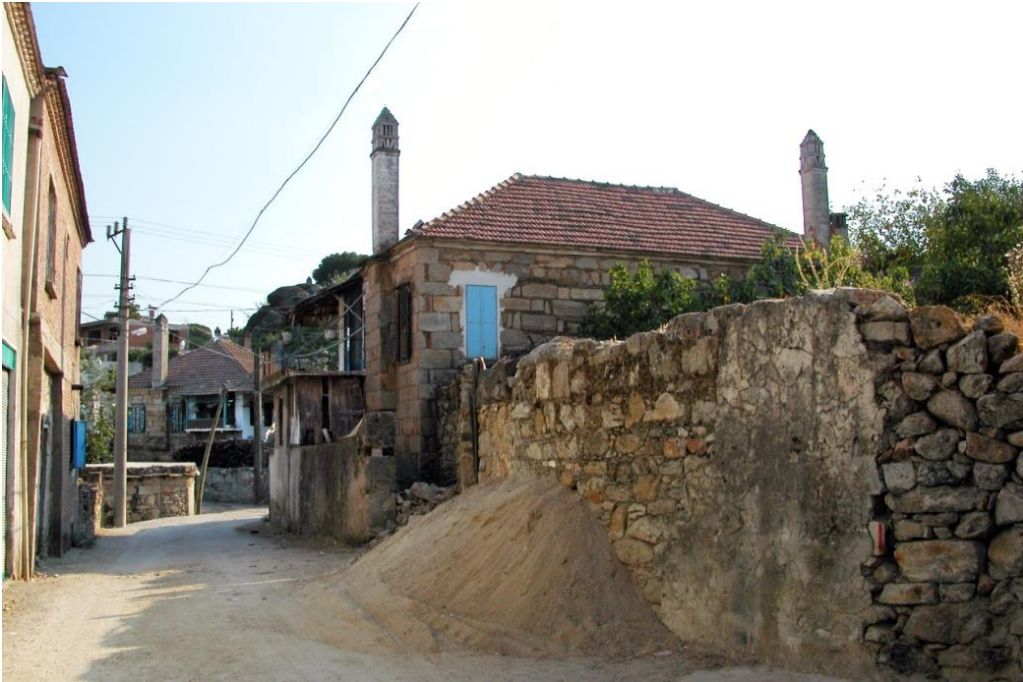
Figure 13. A traditional house from Çomakdağ / Kızılağaç which has two chimneys (photo belongs to the author)

As in the Milas region, one of the most interesting and distinctive elements of the houses in this village are fireplaces and their chimneys. One of the general characteristics of these houses is the reflection of the fireplaces on the facades. The hearths are emphasized by protruding from the facade surfaces. The stone chimneys rising above these roofs are the main elements which forms the physical appearances of these dwellings (Figure 13,14). These chimneys in stone-built houses are interesting characteristic elements with their aesthetic appearance. The chimneys are different from each other. It is understood that each master maked a different chimney form to show his own skill. This is sometimes likened to the chimneys in Milas houses, and sometimes to different animal motifs. Like as half-moon or eagle head figures or by the acroteres of ancient buildings can be seen on the tops of the chimneys and they are made of local slate stones. Also we can claim that some chimneys inspired from the form of Halikarnas Mausoleum or Gümüşkesen Roman Tomb (Figure 15,16) [3,6]. Another detail inspired by Byzantine structures is the eaves of the houses, called “kirpi saçak”(dogs- tooth type), where red and white bricks are used by skipping one another (Figure 17,18). The eaves are made of one original colored brick a white lime-painted brick next to it by knitting them in the same way. It is also possible to come across some eaves built with slate stones obtained from the region. Eave cornices created with stones are usually consist of one or two rows [6].

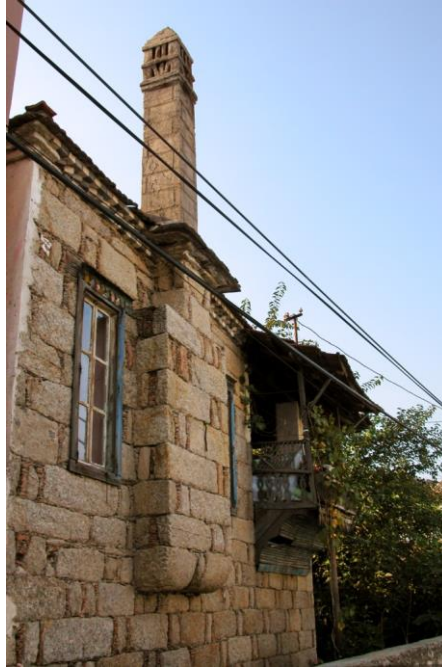
Figure 14. Typical chimney form which projects from the facade (photo belongs to the author)

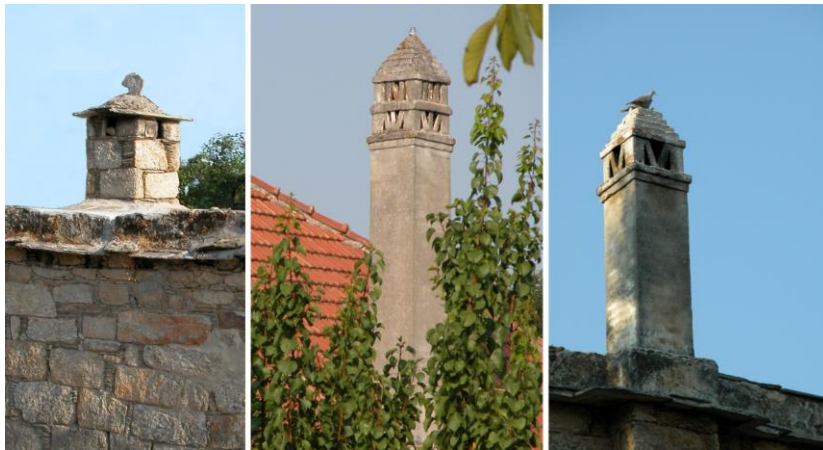
Figure 15. Typical chimneys from Çomakdağ / Kızılağaç which has two chimneys (photo belongs to the author)

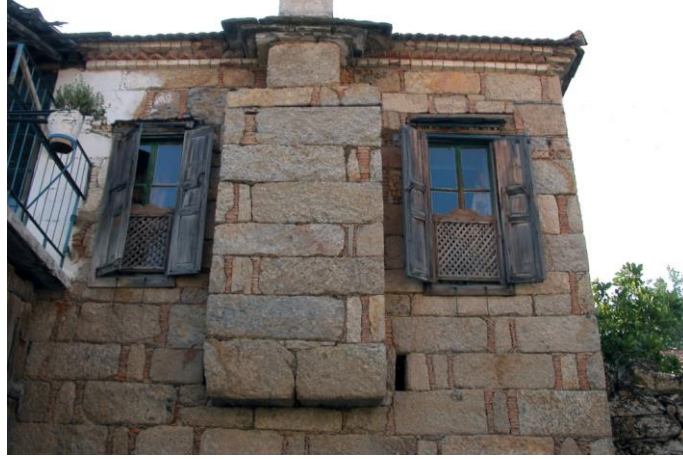
Figure 17. Typical saw teeht “kirpi saçak” eaves (photo belongs to the author)

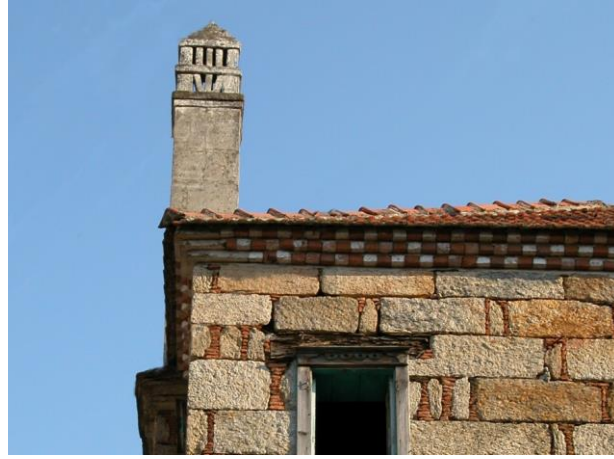
Figure 18. Original cornices of Çomakdağ houses made with three rows of bricks. (photo belongs to the author)

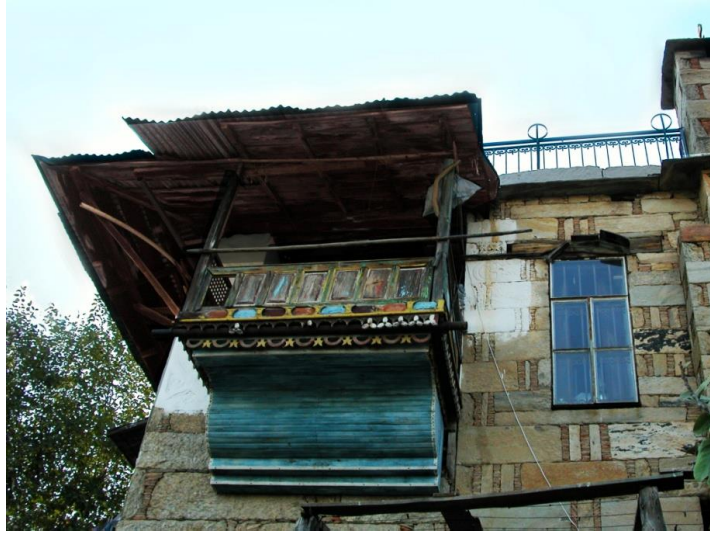
Figure 19. An example from balconies of the Çomakdağ houses. (photo belongs to the author)

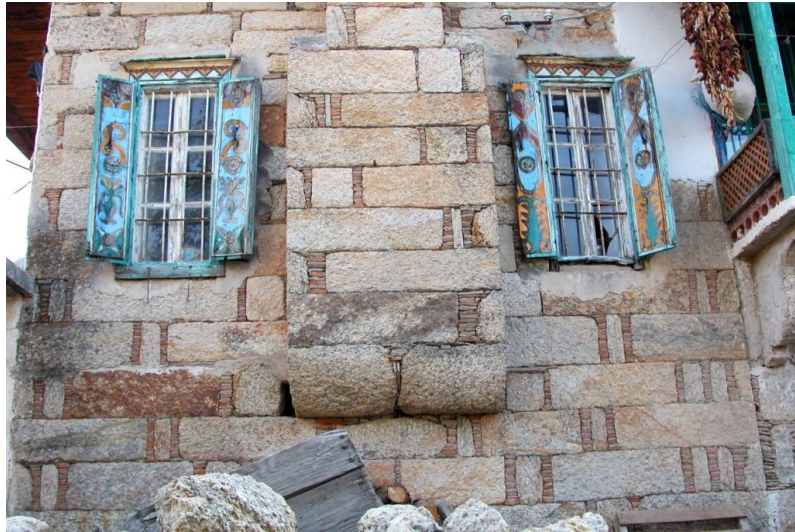
Figure 20. Two examples from shutters of the Çomakdağ houses. (photo belongs to the author)

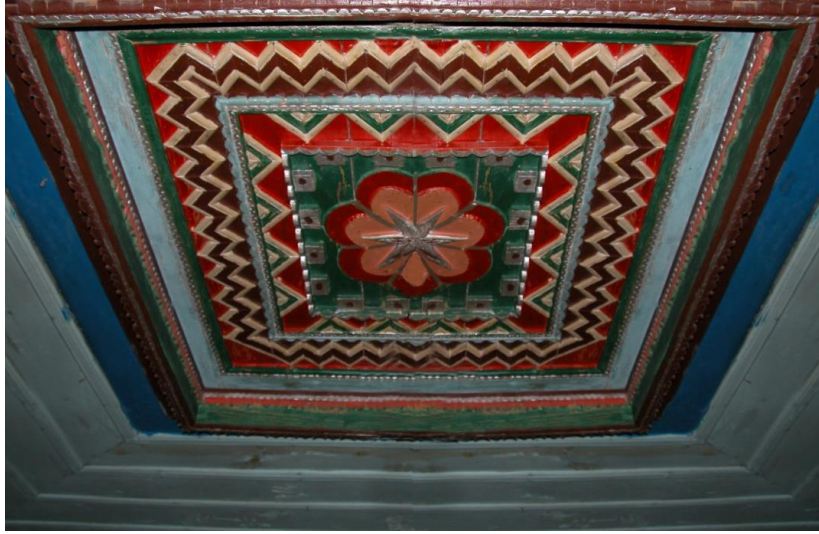
Figure 21. A typical example of ceiling decoration from Çomakdağ- Kızılağaç houses (photo belongs to the author)

floral motifs. Decorations on the timber lathed ceilings are only present at the centers with square or rectangular well ornamented timber elements (Figure 21).

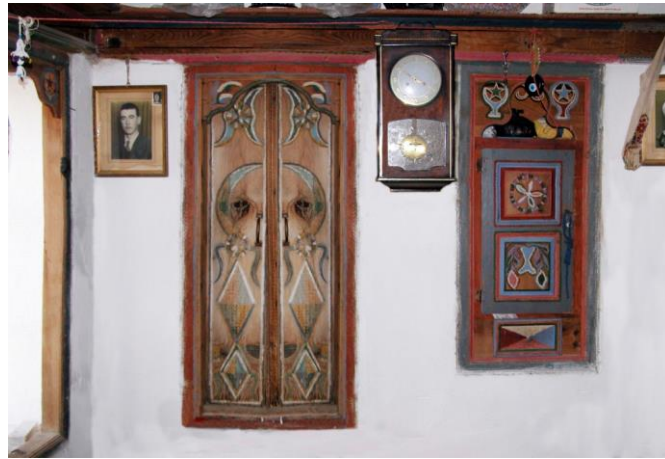
Figure 22. A highly elaborate cupboard decorations (photo belongs to the author)

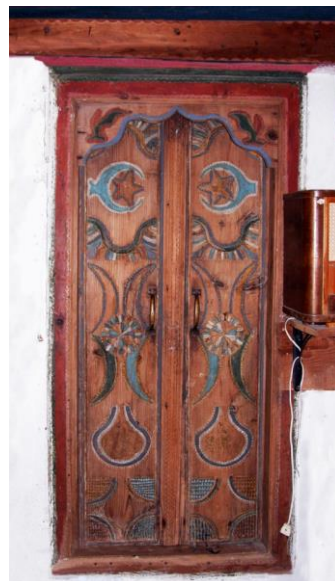
Figure 23. A cupboard doors (photo belongs to the author)

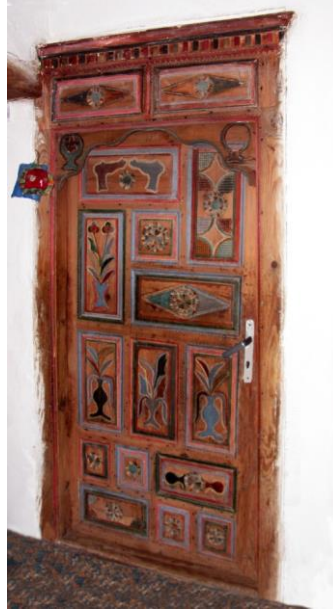
Figure 24. A door example (photo belongs to the author)

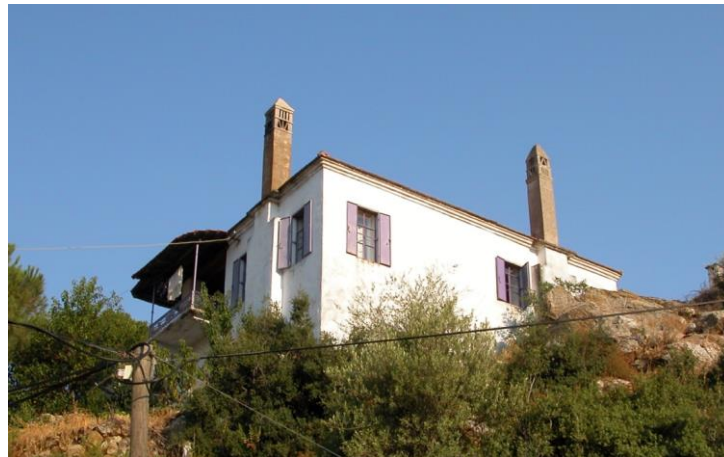
Figure 25. It is seen that the stone facade walls of many residential buildings have been plastered with cement-based plasters and have lost their original appearance (photo belongs to the author)

It is understood that this settlement area maintained its original construction technique and the use of traditional materials until the 1970s [6]. However, after this date, as a result of the increasing population, the desire of more families to live in larger houses and separate from their parents and the lack of new craftsmen to continue the traditional craftsmanship, it is seen that new construction has increased rapidly in the village settlement and many of traditional buildings have been subject to additions and roughy interventions. Moreover, the use of today's readily available common construction materials such as cement, bricks, corrugated sheets, ceramics, etc. in the construction of new buildings and additions to old buildings has led to the deterioration of the characteristic features of the buildings. In addition, the plastering of the original stone wall surfaces and the concealment of the stone masonry cause the general characteristics of the buildings to be lost (Figure 25,26,27).

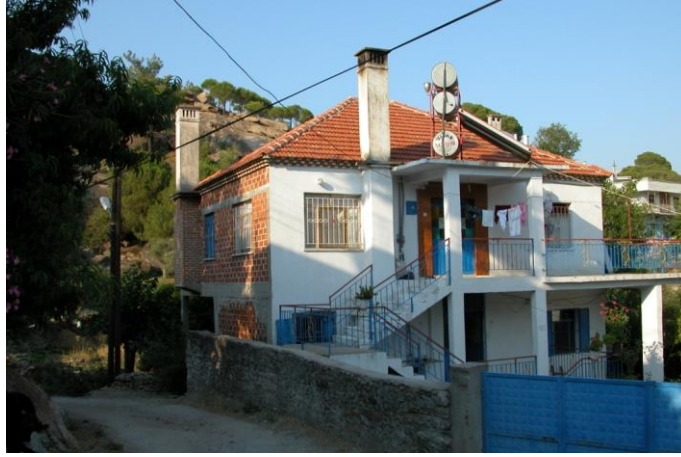
Figure 26. Many of these houses have lost their original features as a result of concrete additions (photo belongs to the author)

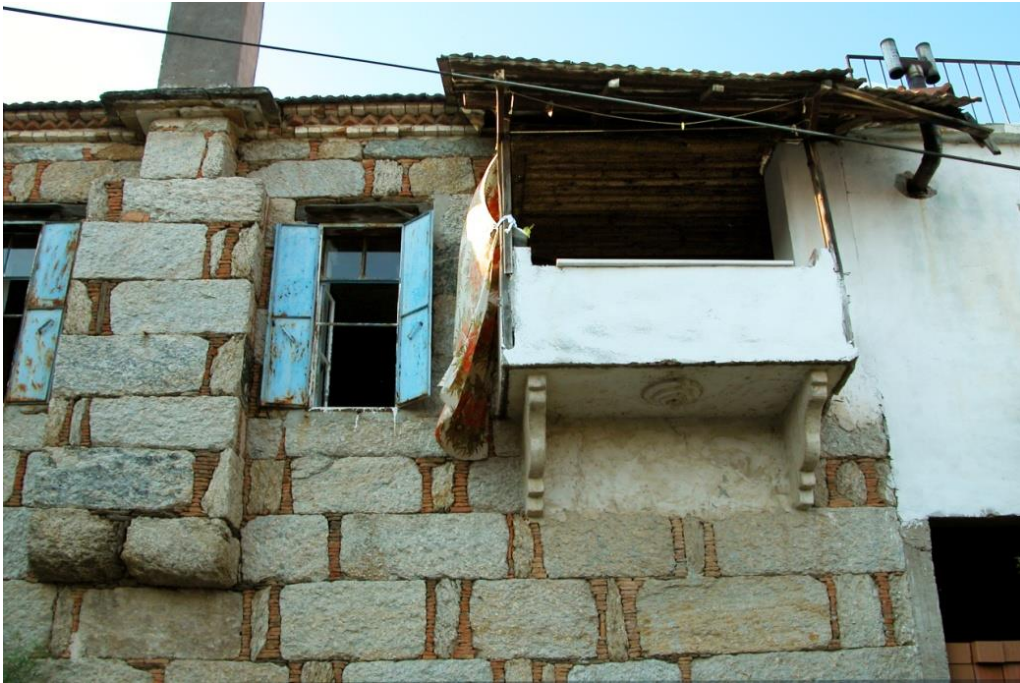
Figure 27. Many of village houses have lost their original features as a result of additions and alterations with inappropriate methods and materials (photo belongs to the author)
