Sustainable Conservation Strategies of Urban Heritage Sites: Kayseri Talas Archaeopark Proposal

Fatma Güler ^{*1}

Research Article

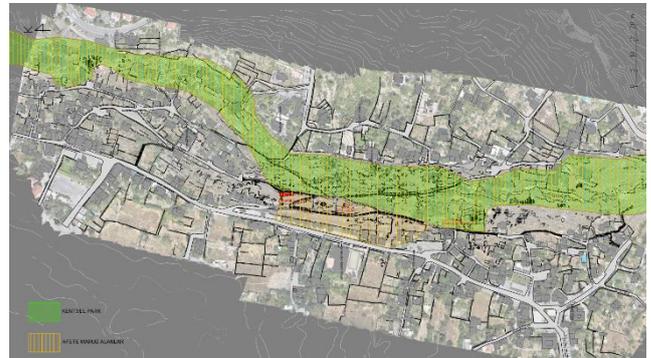
Figure 6. Urban Park and Disaster-Prone Areas on the Orthophoto Site Plan of the Examined Area [25]

The rocky area located in the eastern section of the site, with a height of approximately 20 meters, has been defined as a region at risk of landslides as a result of geological analyses. Due to its topographic features, weak surface stability, and past soil movements, it has been determined that this area exhibits a risky structural condition. Specifically, the geomorphological structure of the region poses a threat to both surrounding settlements and infrastructure elements, as it has the potential to trigger land movements during periods of heavy rainfall. The small-scale landslide events occurred in the past show that the current condition of the area can lead to larger disasters if not intervened. In this context, comprehensive engineering measures such as surface reinforcement, the construction of retaining walls, and the development of drainage systems are recommended to ensure the stabilization of the region.

It is stated that the Talas Municipality has planned interventions, including surface stabilization, the construction of retaining walls, and infrastructure improvements. These efforts are of great importance in both, ensuring the long-term stability of the rocky area and minimizing potential natural disaster risks. Detailed surface evaluations and orthophoto analyses conducted in the area have enabled the precise mapping of risky zones. These data have served as a primary source of information for hazard analyses and the development of conservation strategies to mitigate the effects of potential risks (Figure 6).

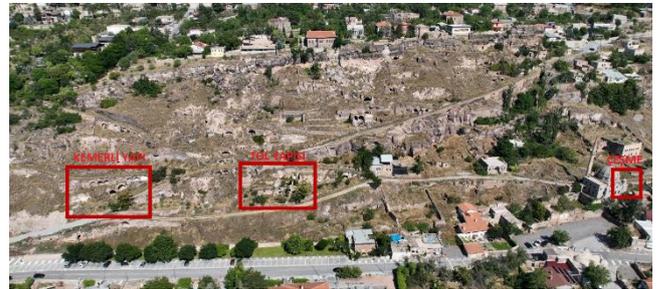
Figure 14. Location of the Arched Structure, Tol Structure and Hacı Ahmet Efendi Fountain [25]

Hacı Ahmet Efendi Fountain, located on Karataş Street, draws attention as an important example of public infrastructure that sheds light on the social history of the region. This fountain, serving functions such as water supply and social interaction, is considered not only from an engineering and architectural point of view but also as a structure addressing the social needs of its time. The architectural details, ornamental elements and building materials of the fountain reflect the aesthetic and technical understanding of its period (Figure 14).

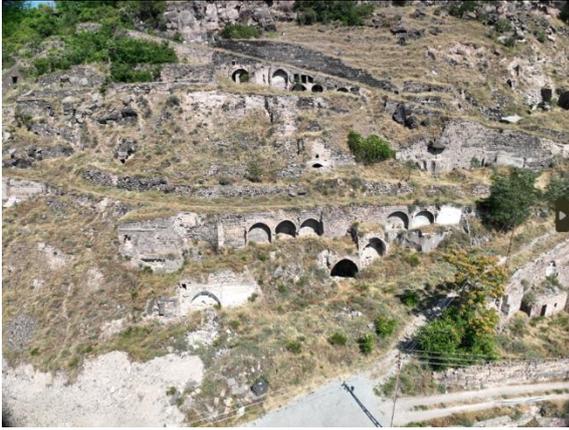
Figure 16. Arched Building General View [25]

Arched structure is located on Çarşı Street, with Karabey Street extending beyond it, leaning against the slope to the east and built in a contiguous order, creating a building complex approximately 47 meters in width. The lower level contains three independent arches, while the upper level features the remains of three interconnected arches and two semicircular arches. The arch spans vary between 340 cm, 360 cm and 395 cm at the lower level while at the upper level between 280 cm and 300 cm. The heights, on the other hand, range from 235 cm to 380 cm at the lower level while at the upper level from 270 cm to 300 cm. Rough dressed stone was used on the main walls and cut stone for the arches (Figure 15,16).

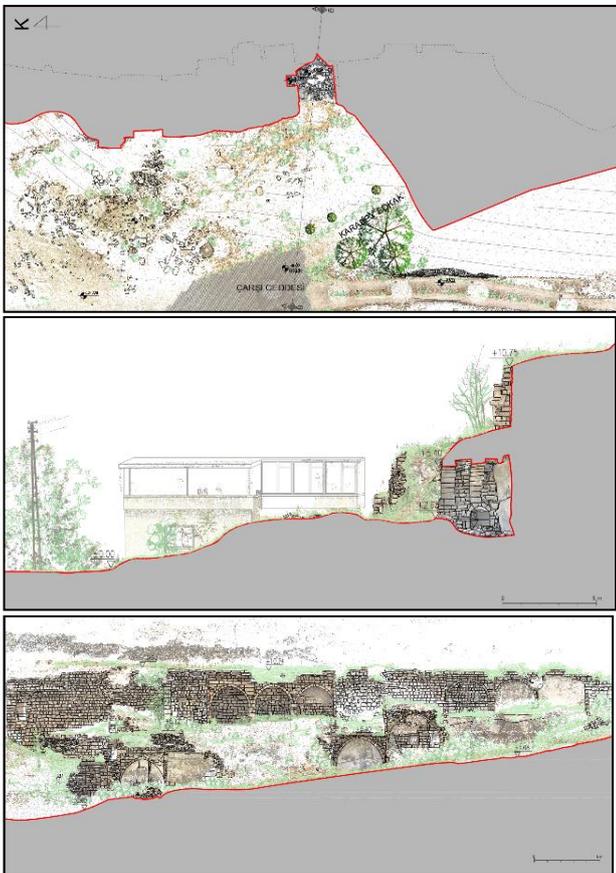
Figure 17. Arched Building +1.660 Elevation Plan, A-A Section and Façade Orthophoto [25]

Some of the arches at the lower level are enriched with niches, and there is a niche measuring 100x105 cm on the north wall of the central arch. The upper coverings are generally in the form of barrel vaults or semicircular arches. In the remains located at the upper level, the arch spans are range from 210 cm to 300 cm, and the structures were similarly built with rough masonry stones. Due to the destruction, a significant portion of the structure has been buried and their floors and upper coverings are sealed by soil fill. These structures feature a structural integrity enriched with interior spaces and rock-carved areas, showcasing remarkable details at both the lower and upper levels (Figure 17).

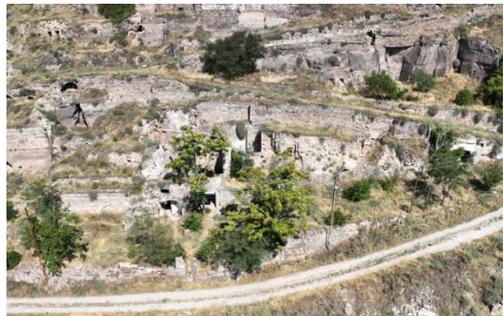
Figure 19. Tol Structure General View [25]

The Tol Structure is located on Çarşı Street, on a sloping land, and it is believed that there are remains of other buildings on it. The building is accessed through a garden wall that surrounds it on three sides. The eastern façade leans against the slope and the main walls of the neighboring structures continue to the north and east. The pathway to the east of the structure leads northward to Karabay Street and southward to Karaman Bayırı. The Tol Structure is considered to be a part of a building complex together with the neighboring remains.

The structure consists of two levels: an entrance and a basement. It has a rectangular plan, approximately 5 meters in width and 10 meters in length. The entrance opening measures 90x180 cm with a window above it measuring 60x120 cm. The interior was built of cut stone, with a vaulted barrel ceiling covering the upper space. (Figure 18,19).

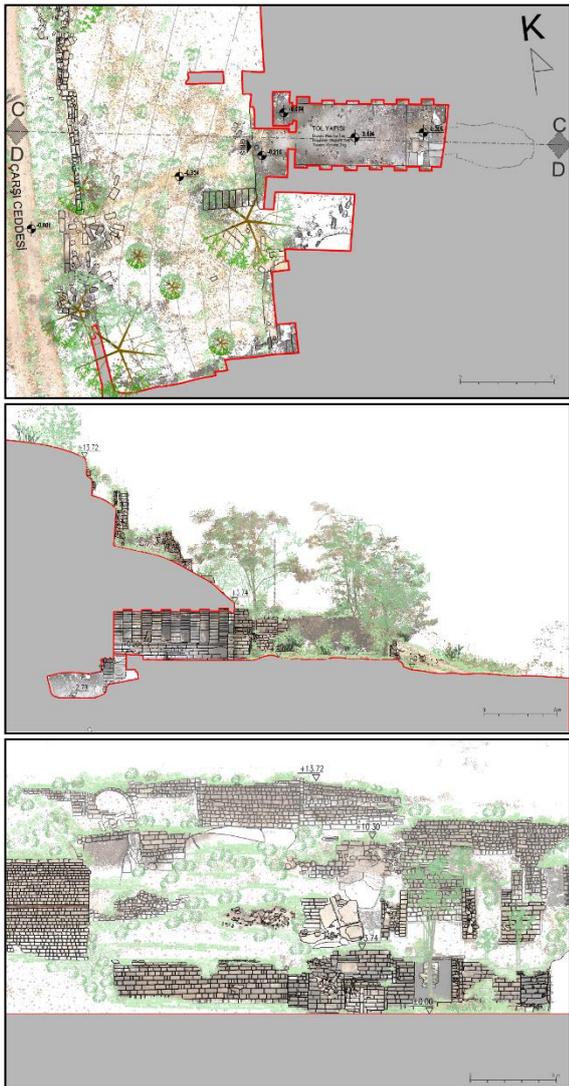
Figure 20. Tol Structure -0.19 Elevation Plan, D-D Section and Façade Orthophoto [25]

A small storage area (alcove) located at the northwest of the structure is separated by an ornate arched opening, measuring 105x180 cm. The walls and the ceiling of the storage area are built with cut stone. On the eastern side, a passage in the ground leads to the cellar on the lower level through a staircase. The cellar has an oval plan measuring 240x550 cm and is covered with a vaulted barrel ceiling. There are two niches in the walls of the cellar (Figure 20).

The demolished stairs and the steps above the entrance found in the garden indicate the existence of another place at a higher level in the past. Rough masonry stone was used on the exterior of the structure and cut stone in the interior. However, some parts have been damaged due to serious destruction and soil fill throughout the structure.

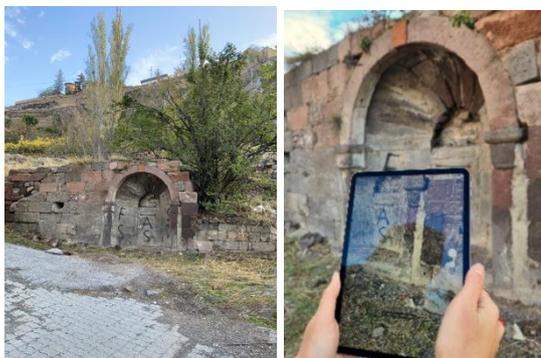
Figure 22. Hacı Ahmet Efendi Fountain and LIDAR Scanning Process [25]

Hacı Ahmet Efendi Fountain is located on a sloping land within a garden wall, bordered to the west by Beybağı Street and to the north and south Karataş Street. The fountain, with its eastern façade leaning against the slope, is part of a wall approximately 30 meters long, located southeast of the Han Mosque. According to the measurements, the fountain measures 2.35 m in width, 2.60 m in height and 1.28 m in depth (Figure 21,22).

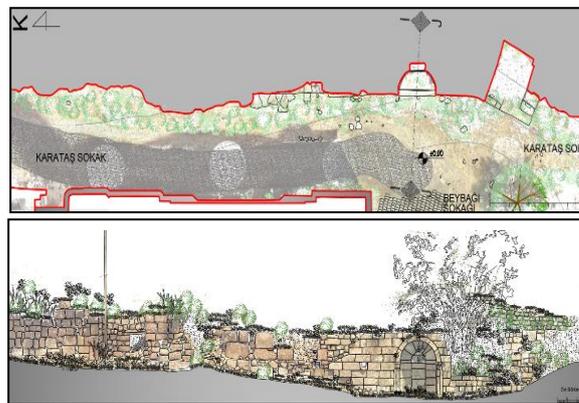
Figure 23. Hacı Ahmet Efendi Fountain +0.32 Elevation Plan and Façade Orthophoto [25,27]

The fountain constructed from cut stone features a single facade with rounded arches. The niche, supported by two square plaster pillars, is covered by a half-dome constructed with a radial stone arrangement. The stone arrangement above the niche is also observed in the Göllü Fountain and the Gevher Nesibe Fountain in Kayseri. The fountain, which once had an inscription written in thuluth script, was damaged over time, lost its neighborhood identity due to the elevation of the road level and became non-functional (Figure 23).

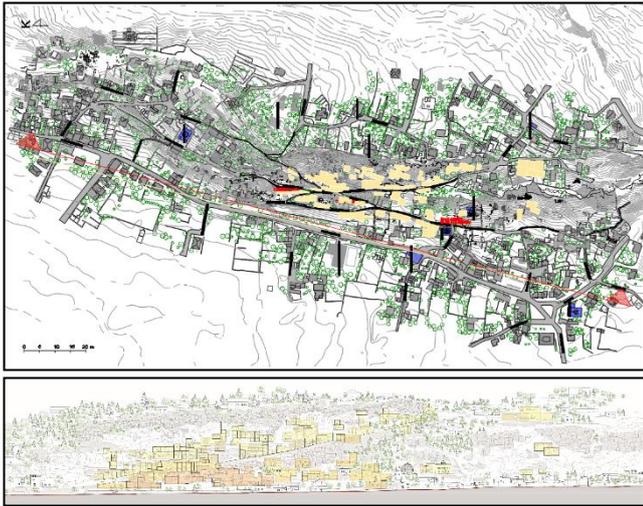
Figure 24. Proposal for the Site Plan and Silhouette Restoration of Talas Urban Archaeological Site [25]

In the design of Talas Archaeological Park, it is proposed to integrate monumental structures such as Ottoman Street, Tol structures, and churches into a thematic tour route. This route would be complemented by walking and cycling paths to enhance the visitor experience of the archaeological sites.

- Local and National Collaborations: A multi-stakeholder management system involving municipalities, universities, and non-governmental organizations.
- Training and Awareness Programs: Organizing training programs and events to enhance local community participation in the project (Figure 24,25).

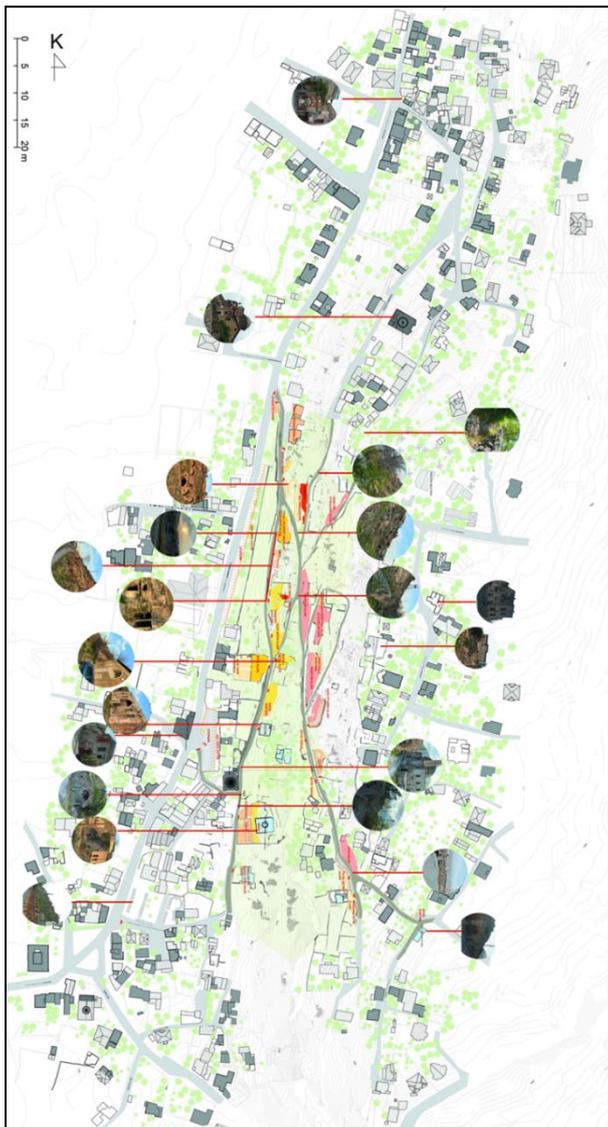
Figure 25. Proposal for the Archaeological Park of Talas Urban Archaeological Site [25]
