# Investigation of the effects of precision-casting waste sands on the thermal shock resistance properties of fire clay refractory materials

Veysel Murat Bostancı<sup>1\*</sup>

, Tuba Bahtlı<sup>2</sup>

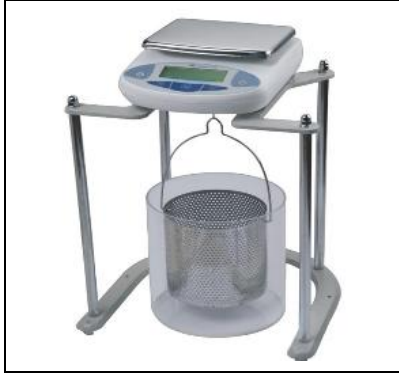
Figure 1. Archimedes principle.

porosity tests conducted through the Archimedes principle (Figure 1) are presented in equations 1 and 2.

The samples were placed in the apparatus and weighed on a precision balance, determining their weights in water ( $w_b$ ). Subsequently, the samples, after being removed from the water, were wiped with a paper towel to remove surface water, and their wet weights were determined using a precision balance ( $w_c$ ). In the final step, after drying the samples in an oven, their dry weights were measured using a precision balance ( $w_a$ ). The visible porosity (%) and bulk density values were calculated using Equation 1 and Equation 2 data, as per the British Standard [27].

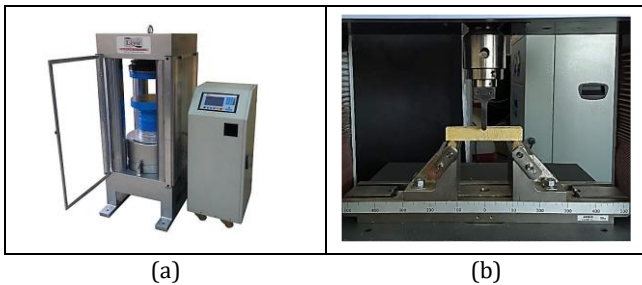
Figure 2(a): Cold crushing strength and (b): Three-point bending test.

Tests were conducted according to ASTM-C133 standards for cold crushing strength Figure 2(a). The strength values were calculated by dividing the maximum pressure the material could withstand by the cross-sectional area. Three-point bending tests were performed on a Shimadzu AGS-X device by ASTM-C1161-90 standards. Samples with dimensions of 25 mm x 25 mm x 150 mm were subjected to the three-point bending test Figure 2(b), and strength and toughness values were calculated based on the obtained data.
